Nature of Work: FIRE REPAIR: REPLACE CEILING JOIST OVER PARKING AREA

Report Number: One  
July 2, 2001

**LOSS LOCATION:** 2030 V Street, Sacramento, CA 95818

You assigned ENGINEERING AND FIRE INVESTIGATIONS to inspect the structural damage at the CALIFORNIA ASSOCIATION OF HIGHWAY PATROLMEN. You indicated that a fire had occurred underneath the building in the carport. You needed to know the extent of the fire damage and recommendations for repair.

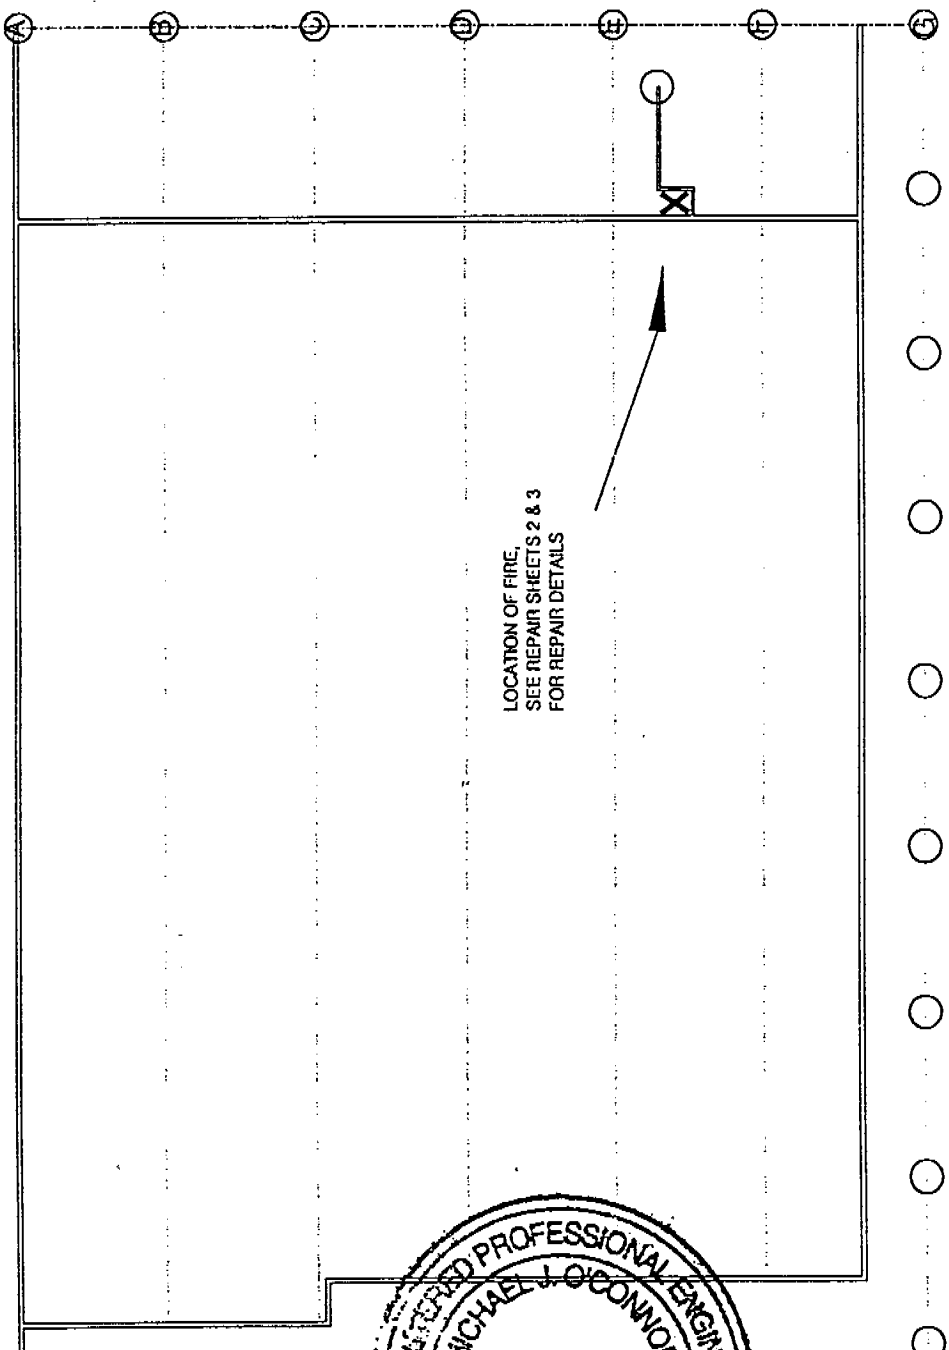
# REPAIR PLAN SHEET 1

The fire occurred in the carport area which was on the west side of the building. Apparently, a gas line leaked and the gas was ignited providing the fuel for the fire. The area of origin of the fire was clearly defined by the burn patterns on the adjacent walls.

LOCATION OF FIRE.  
SEE REPAIR SHEETS 2 & 3  
FOR REPAIR DETAILS

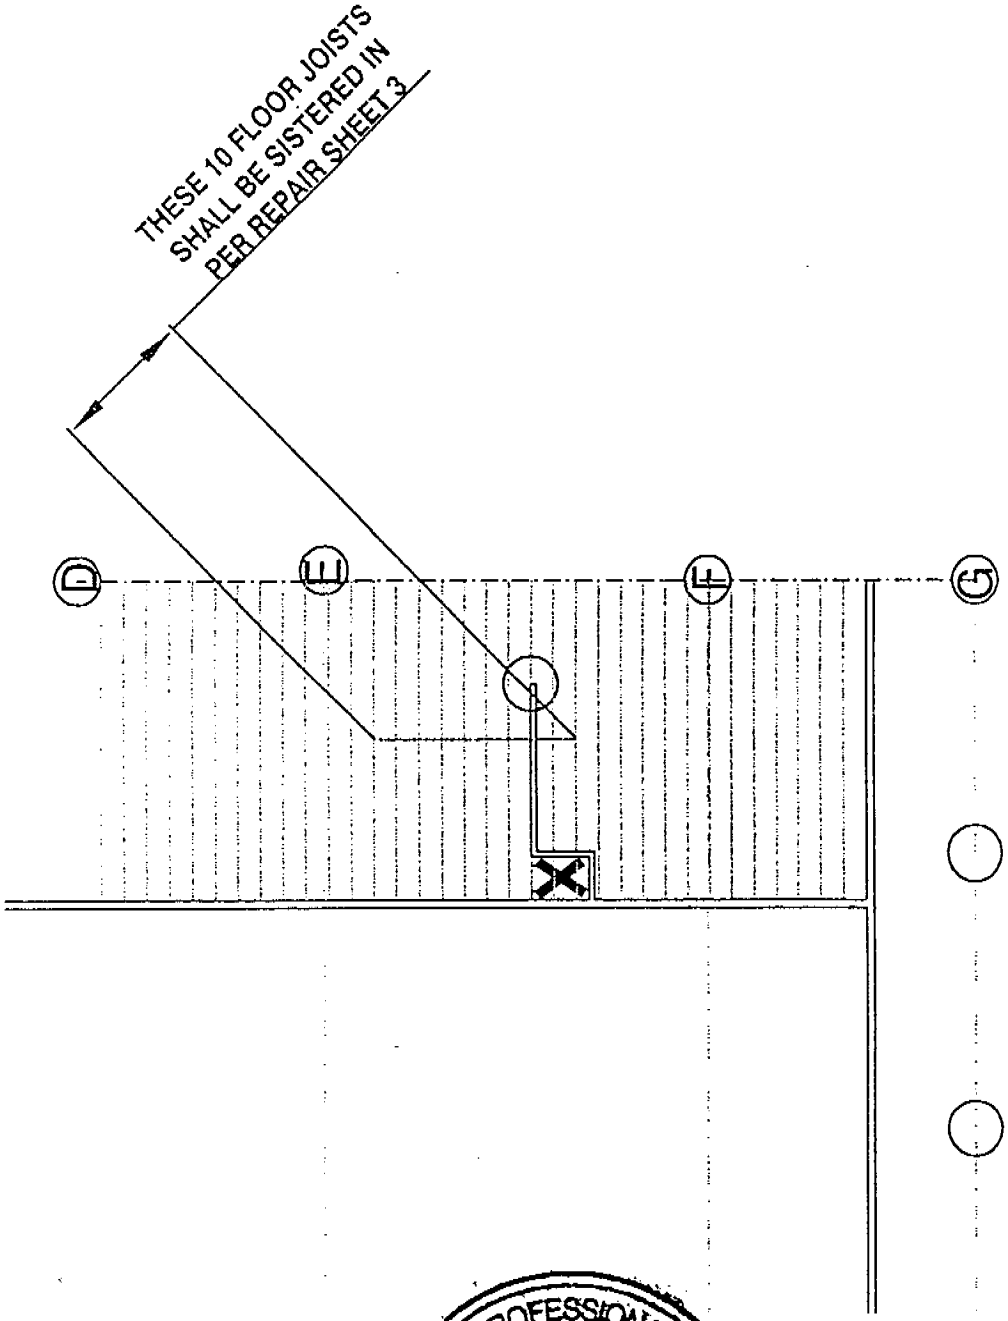
REPAIR PLAN SHEET 2

The fire broke through the Portland cement plaster soffit of the carport area and caused damage to the 2x14 floor joists that were supporting the room above. There was a total of 10 floor joists which were damaged by the fire. These floor joists will need to be sistered with new 2x14 floor joists and attached to the wall per the attached drawings and specifications.

The 2x14 floor joists above the area of origin were severely damaged. A total of 10 floor joists will need to be sistered with new 2x14 joists. The attached plans show the detail for installing these reinforcing joists.

THESE 10 FLOOR JOISTS  
SHALL BE SISTERED IN  
PER REPAIR SHEET 3

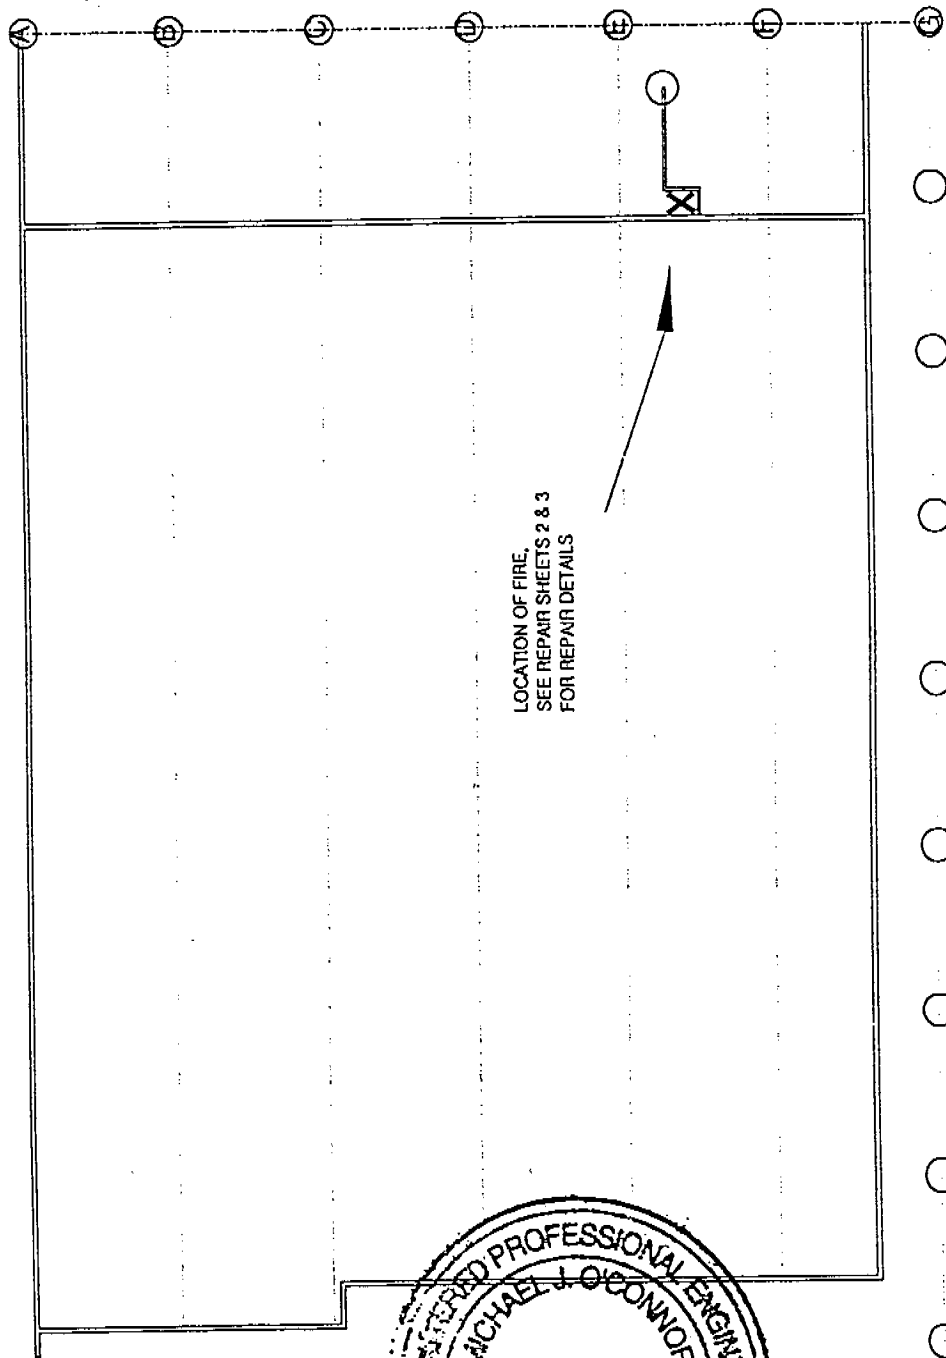
# REPAIR PLAN SHEET 1

LOCATION OF FIRE.  
SEE REPAIR SHEETS 2 & 3  
FOR REPAIR DETAILS

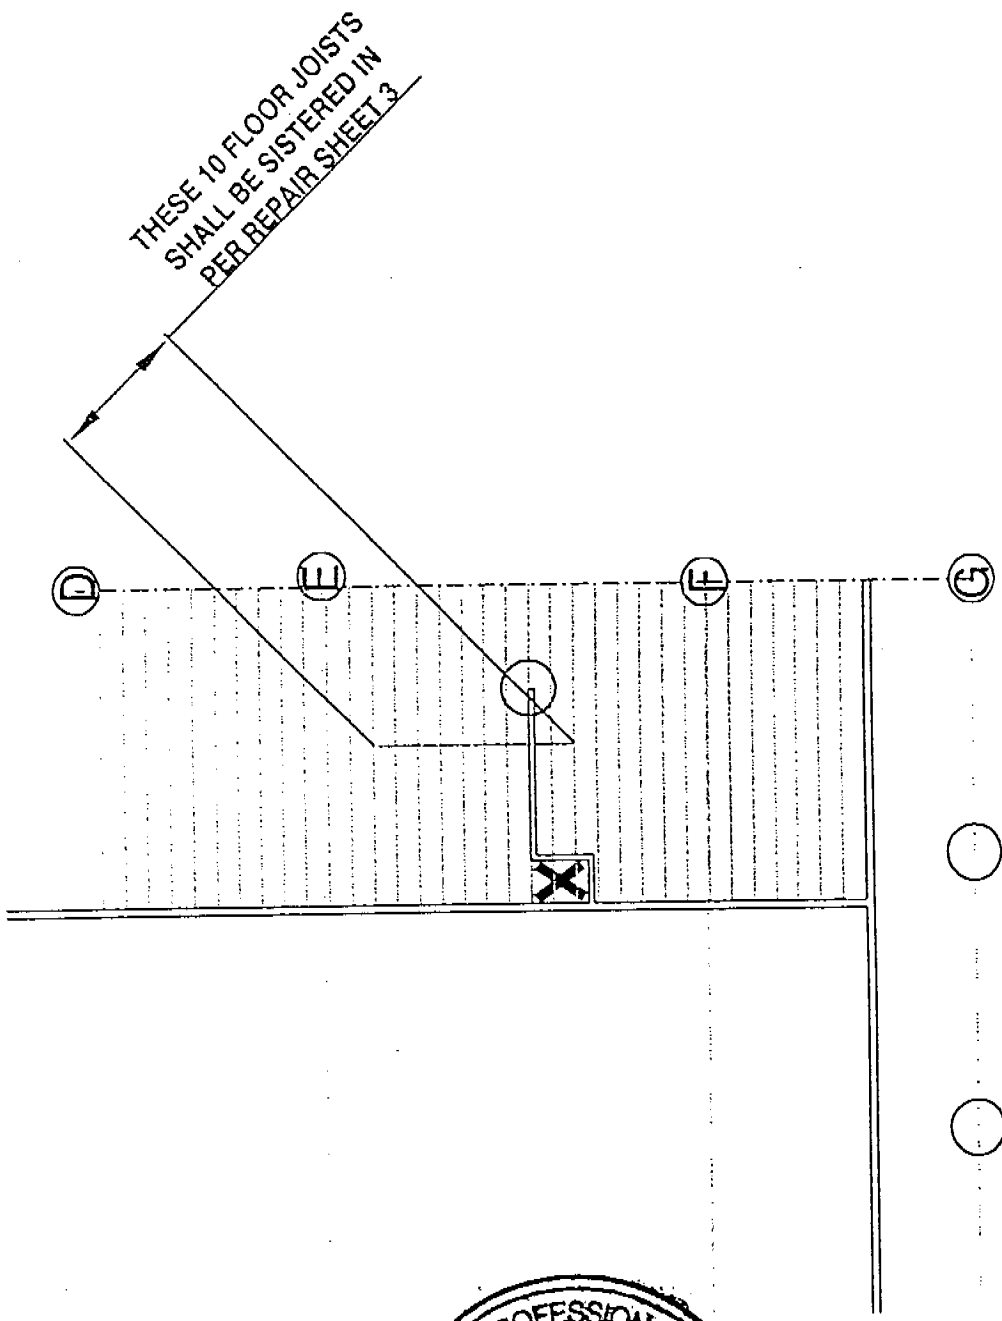
Job Name CALIFORNIA ASSOCIATION OF HIGHWAY PATROLMEN		Scale 1/8"	
Technician MARTIN	Date 6/18/01	<b>REPAIR PLAN SHEET 2</b>

The 2x14 floor joists above the area of origin were severely damaged. A total of 10 floor joists will need to be sistered with new 2x14 joists. The attached plans show the detail for installing these reinforcing joists.

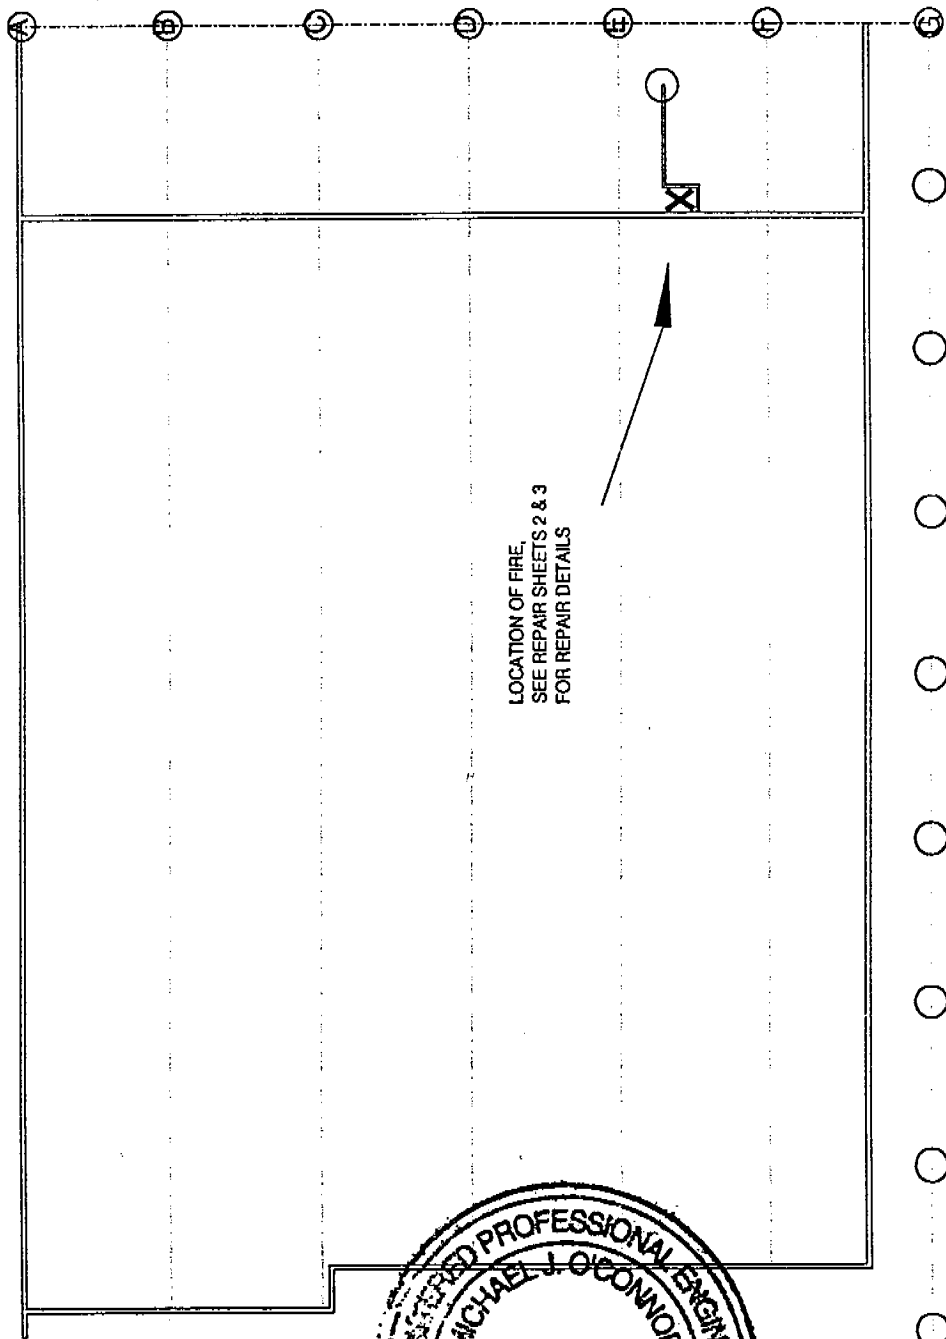
REPAIR PLAN SHEET 1

The fire occurred in the carport area which was on the west side of the building. Apparently, a gas line leaked and the gas was ignited providing the fuel for the fire. The area of origin of the fire was clearly defined by the burn patterns on the adjacent walls.

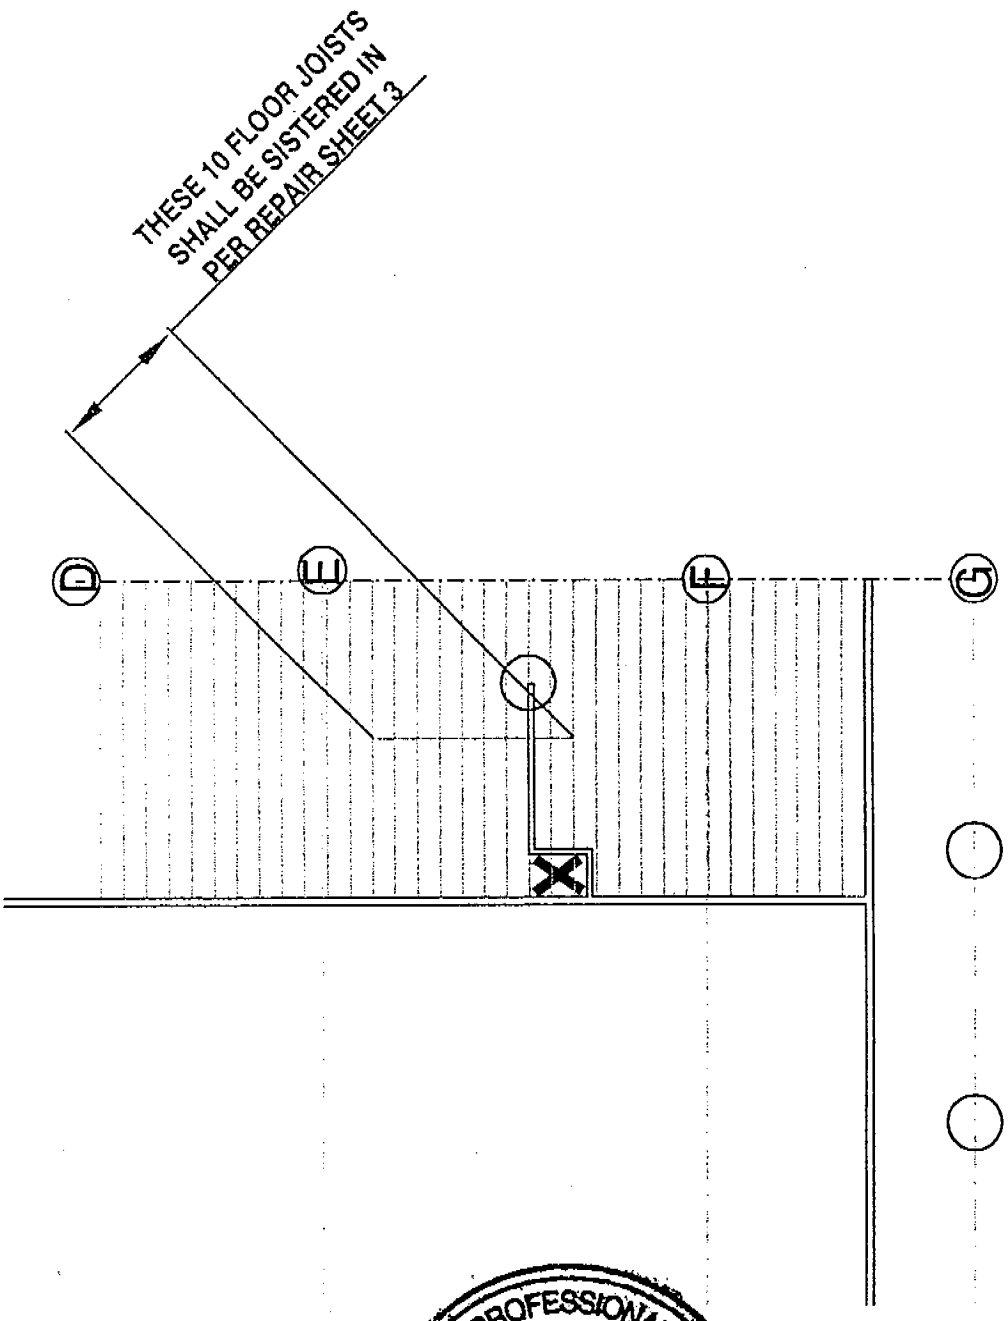
REPAIR PLAN SHEET 2

The 2x14 floor joists above the area of origin were severely damaged. A total of 10 floor joists will need to be sistered with new 2x14 joists. The attached plans show the detail for installing these reinforcing joists.
