SUBJECT: MEMORIAL AUDITORIUM RENOVATION
Rehabilitation Program

**SACRAMENTO
MEMORIAL
AUDITORIUM**

**A
REHABILITATION
PROGRAM**

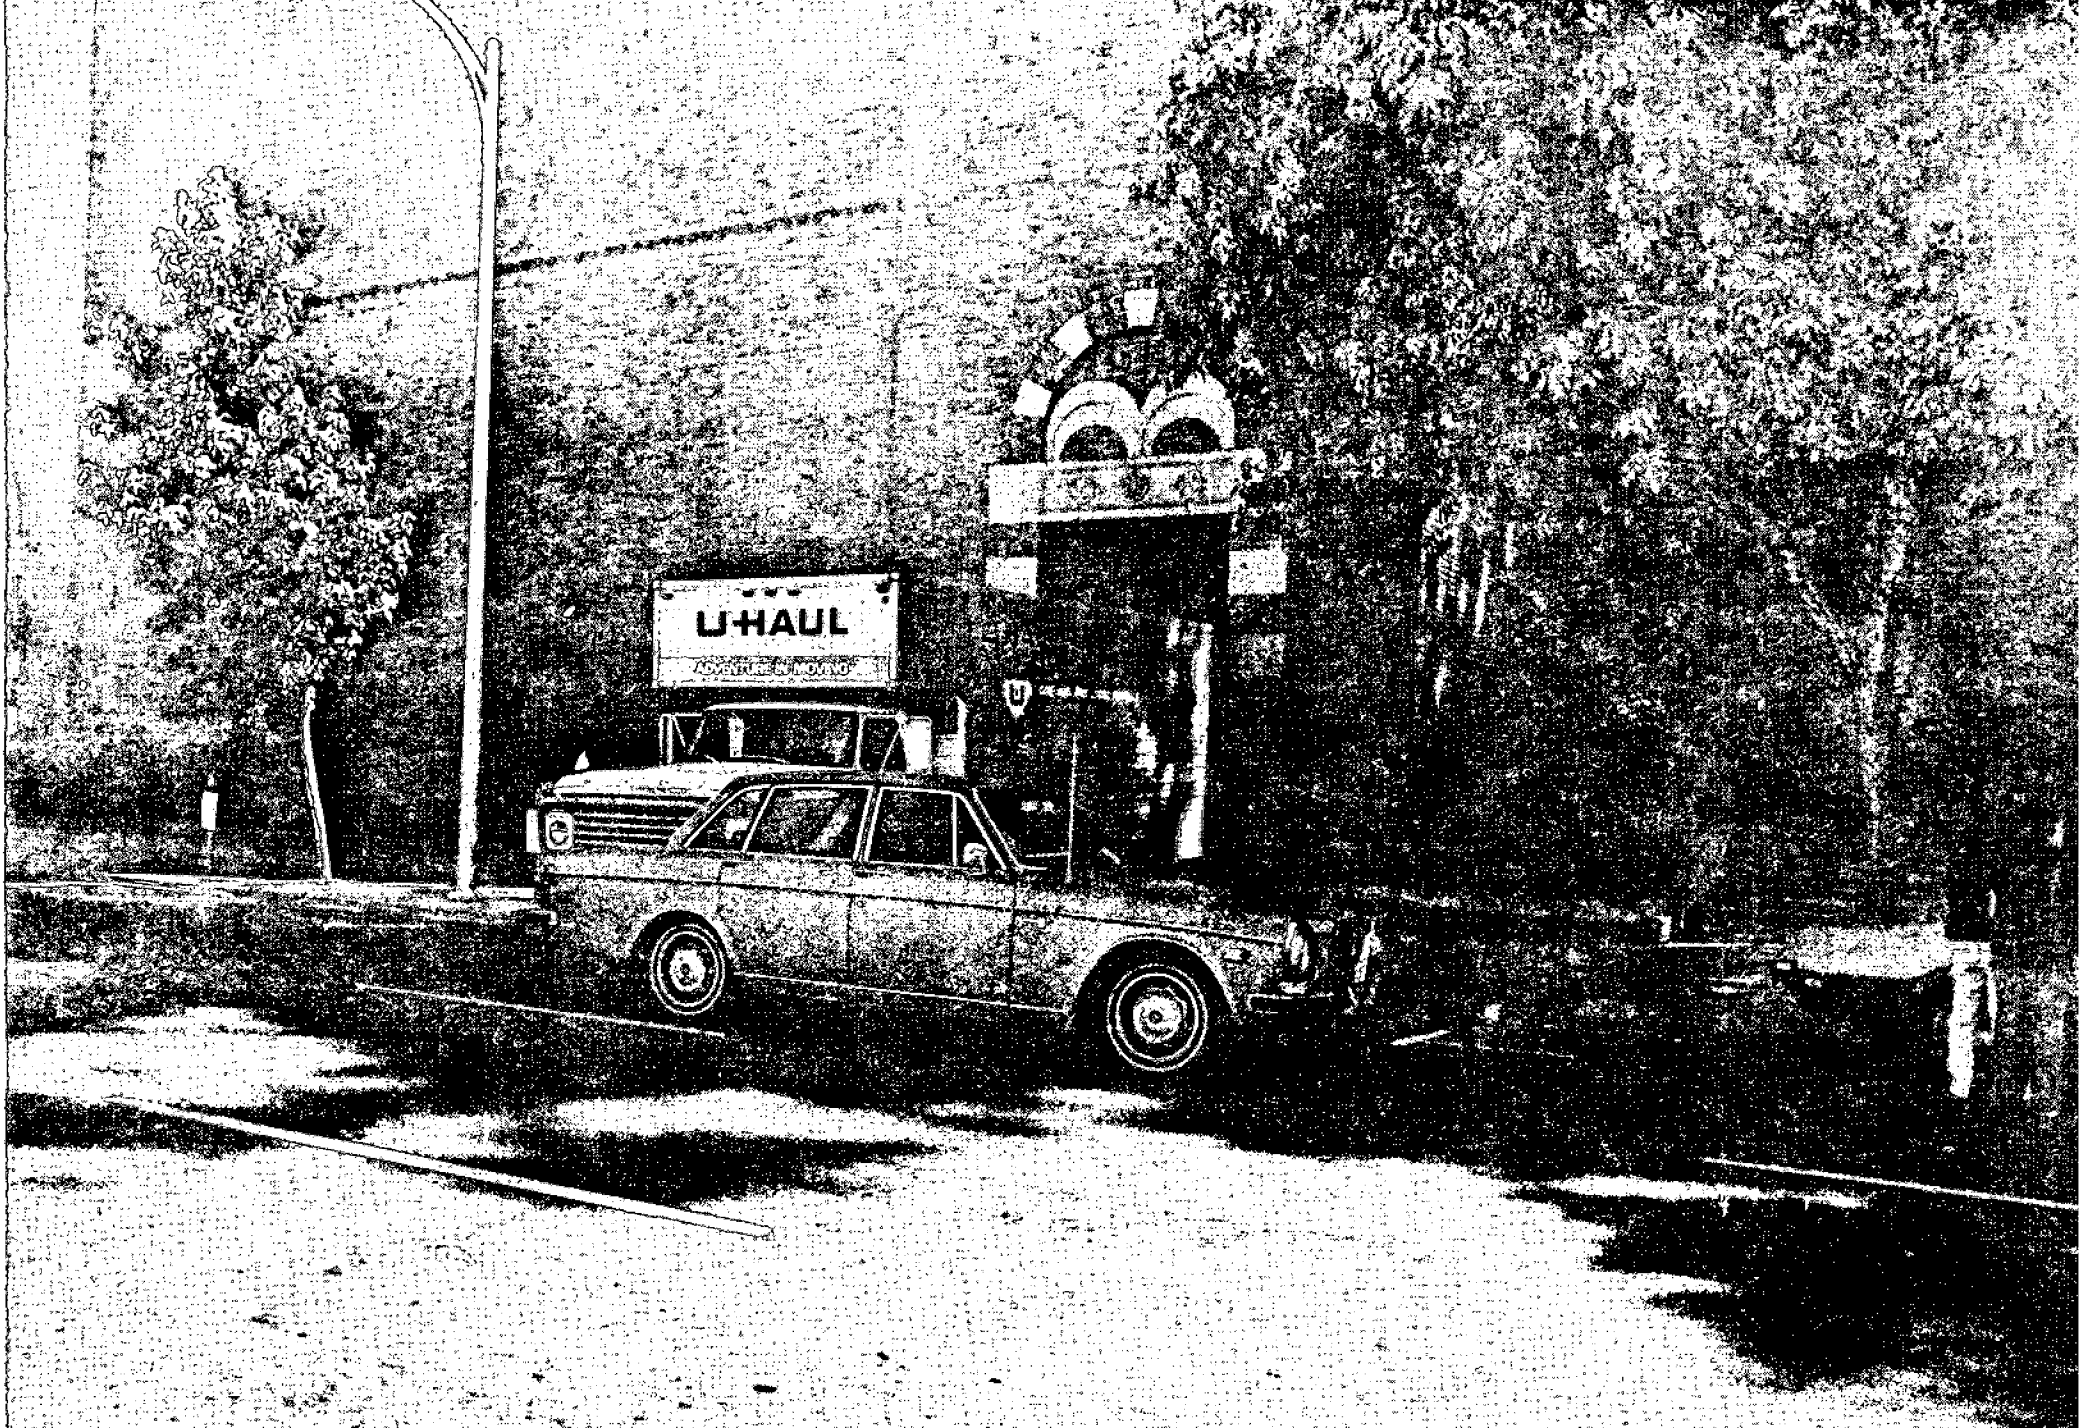
The most obvious deficiency of the site/complex is the dock loading doors to the stage which affront "I" Street. The ramping driveways to the basement are too narrow and steep for modern vehicular use. Event production loading/unloading to the stage as well as refuse removal and concessionaire off-loading cannot be done without disrupting two or more lanes of

STAGE DELIVERY DOORS AT J STREET. PROPOSED WORK WOULD PROVIDE AN ON-SITE TRUCK DOCK AND EFFECTIVELY ELIMINATE VEHICULAR AND PEDESTRIAN HAZARDS.

traffic along "I" Street. A 16th Street on-site dock at the stage would relieve the "I" Street traffic problems as well as provide an area for waste removal and concessionaire deliveries. (See Appendix, Diagram One.)

Develop a stage-level dock entrance for at least one truck, backed up to the stage and off the street. The upstage left corner (auditorium's northeast corner) is our recommended position. This dock area would also serve City refuse collection. The development of this on-site truck dock necessitates the filling of the existing northeast ramp driveway to the basement and the sealing of its door. The remaining ramp in the northwest corner will remain to service the basement directly from the outside. (See Appendix, Diagram One.)

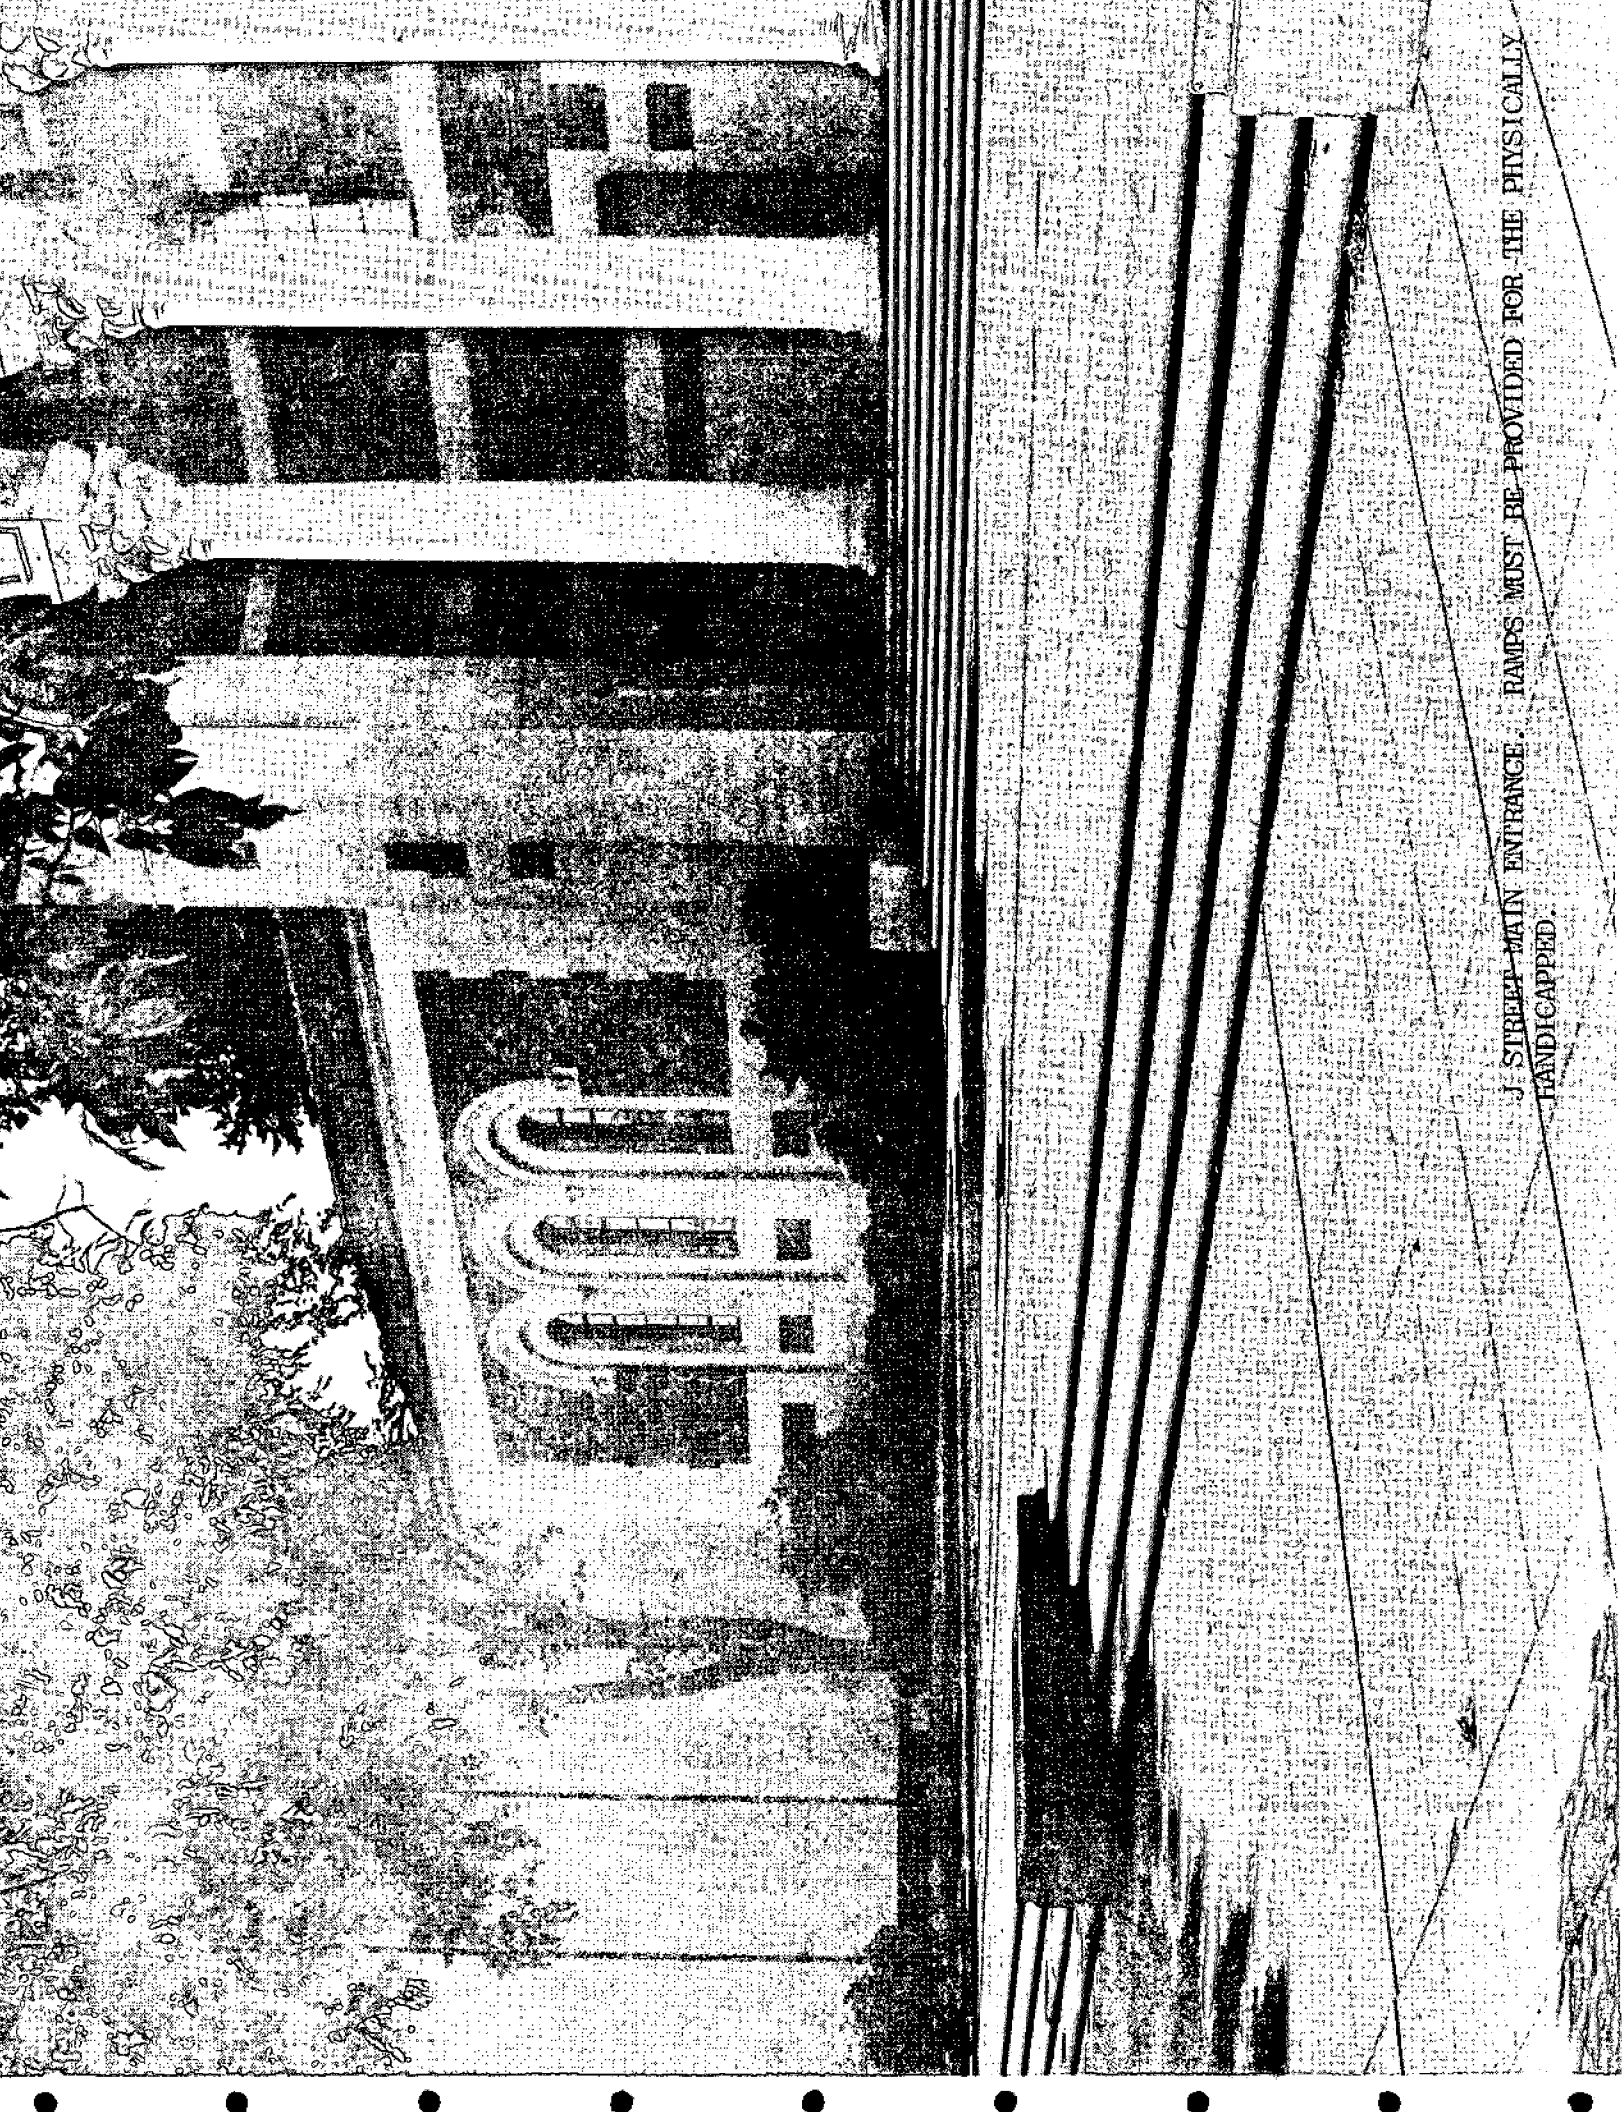
J STREET MAIN ENTRANCE. RAMPS MUST BE PROVIDED FOR THE PHYSICALLY HANDICAPPED.

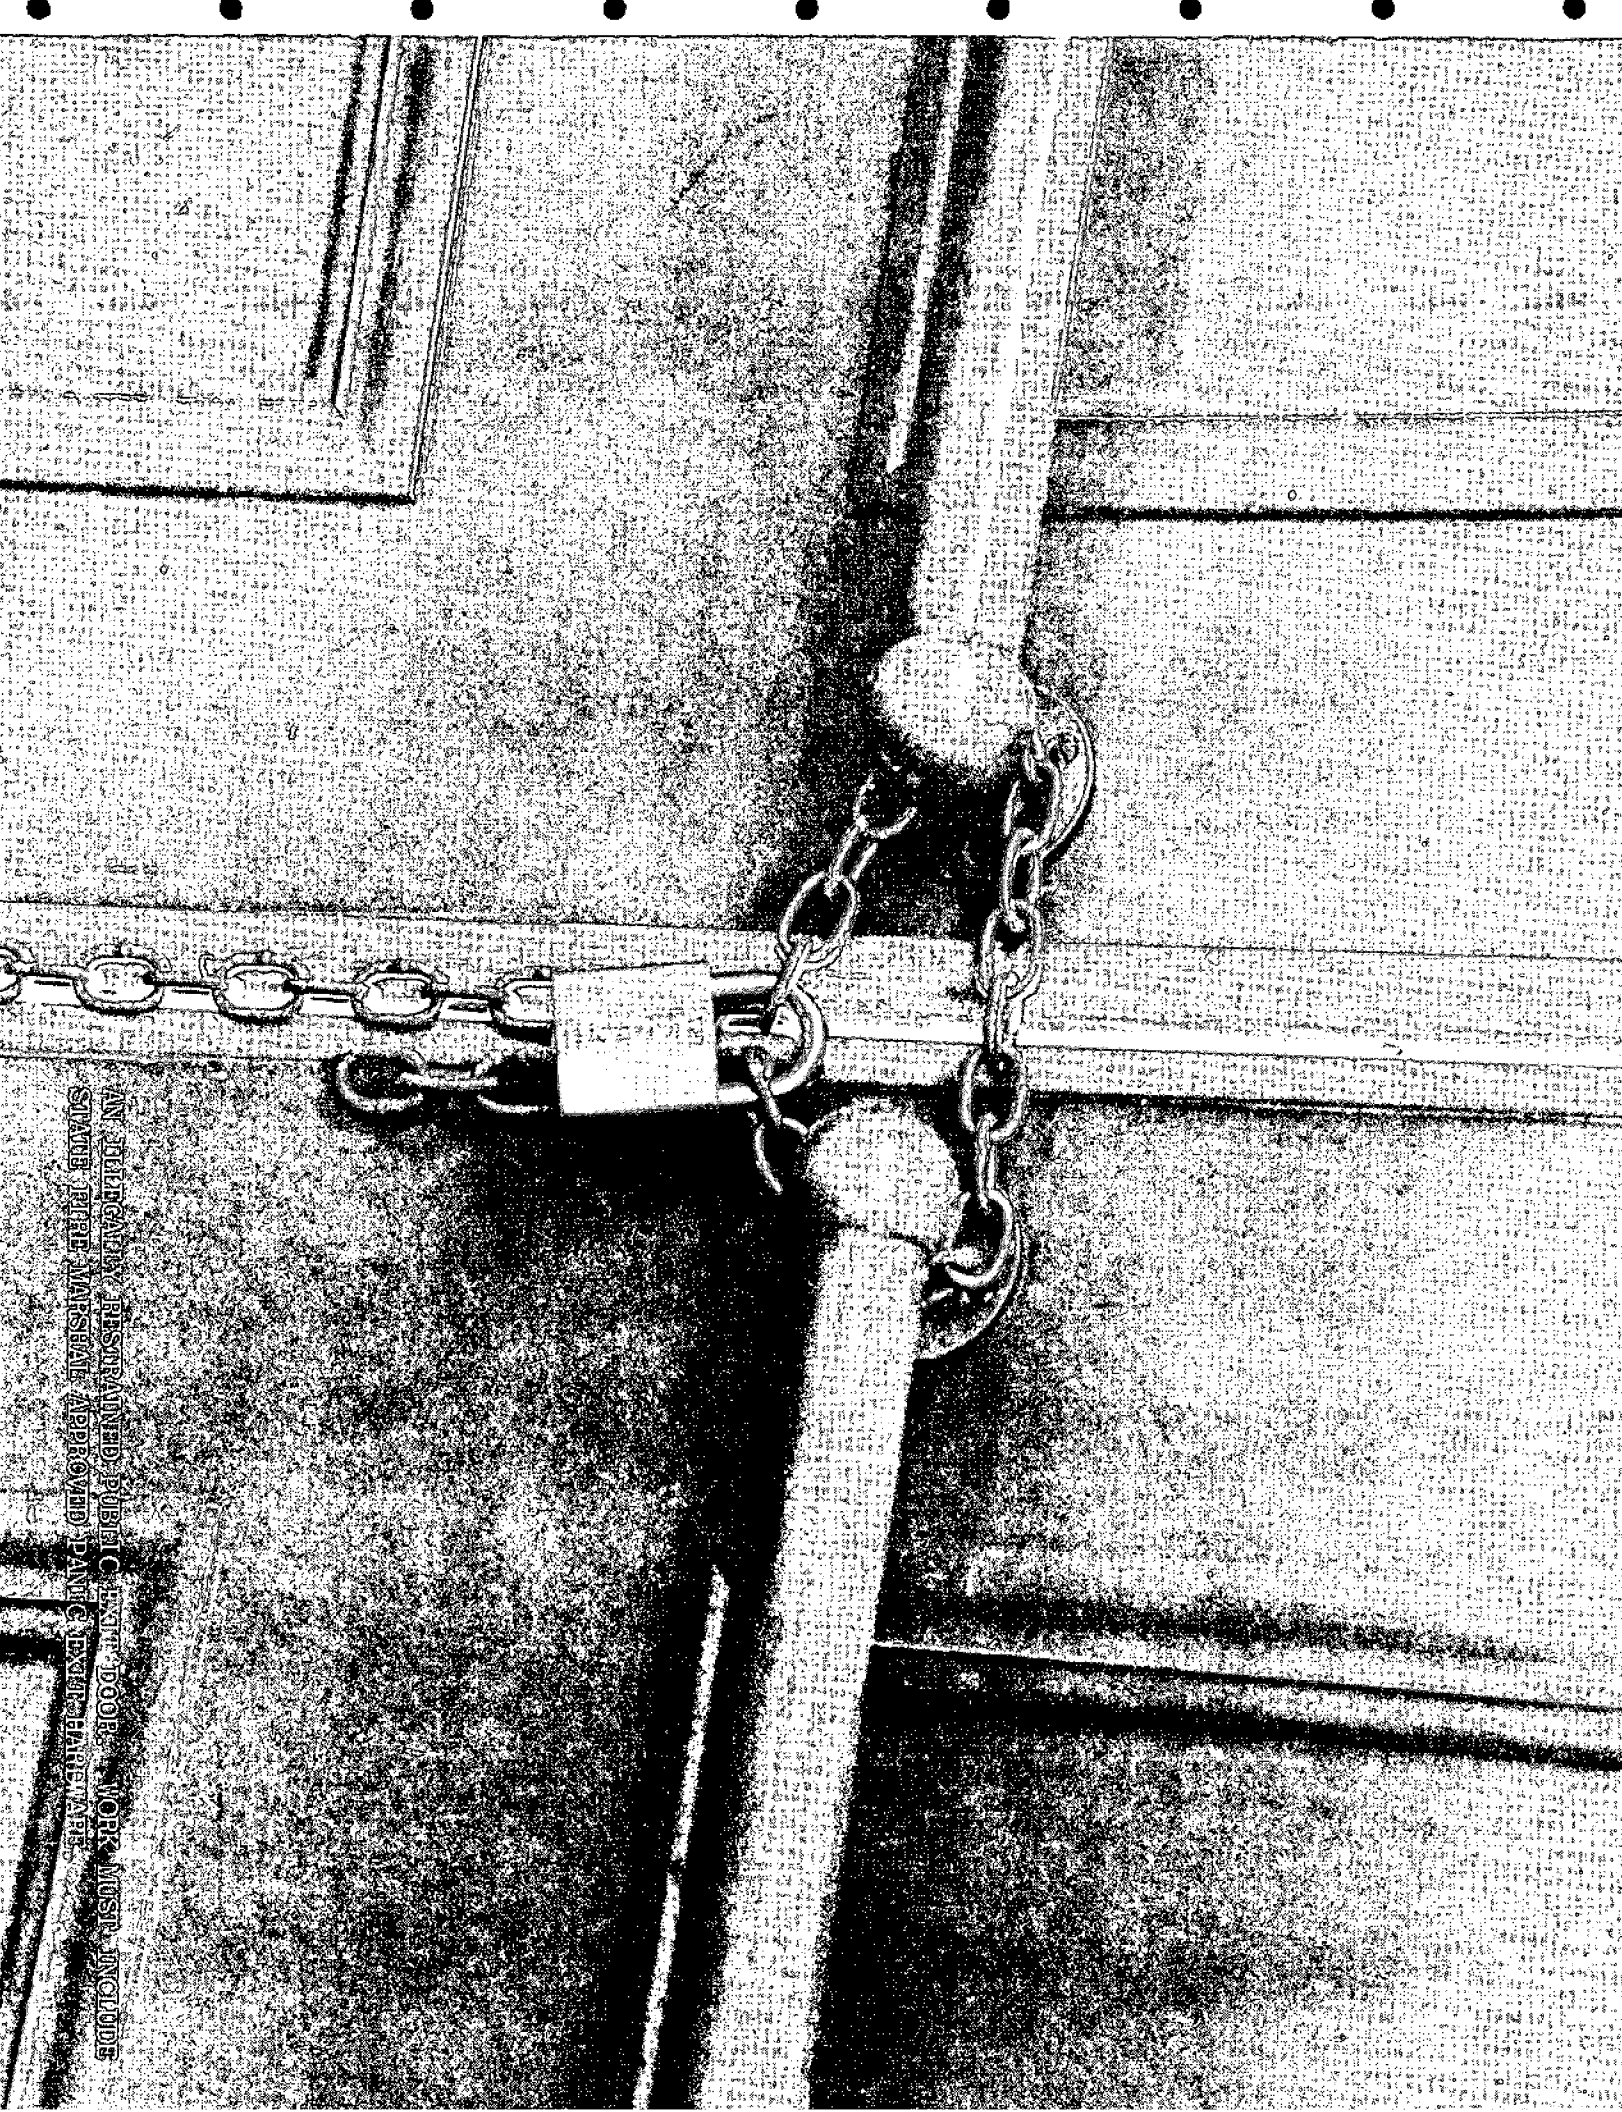
AN ILLICITLY RESTRAINED PUBLIC CARRY DOOR - WORK MUST INCLUDE
STATE FIRE MARSHAL APPROVED DANC C EVIDENCE MARKING

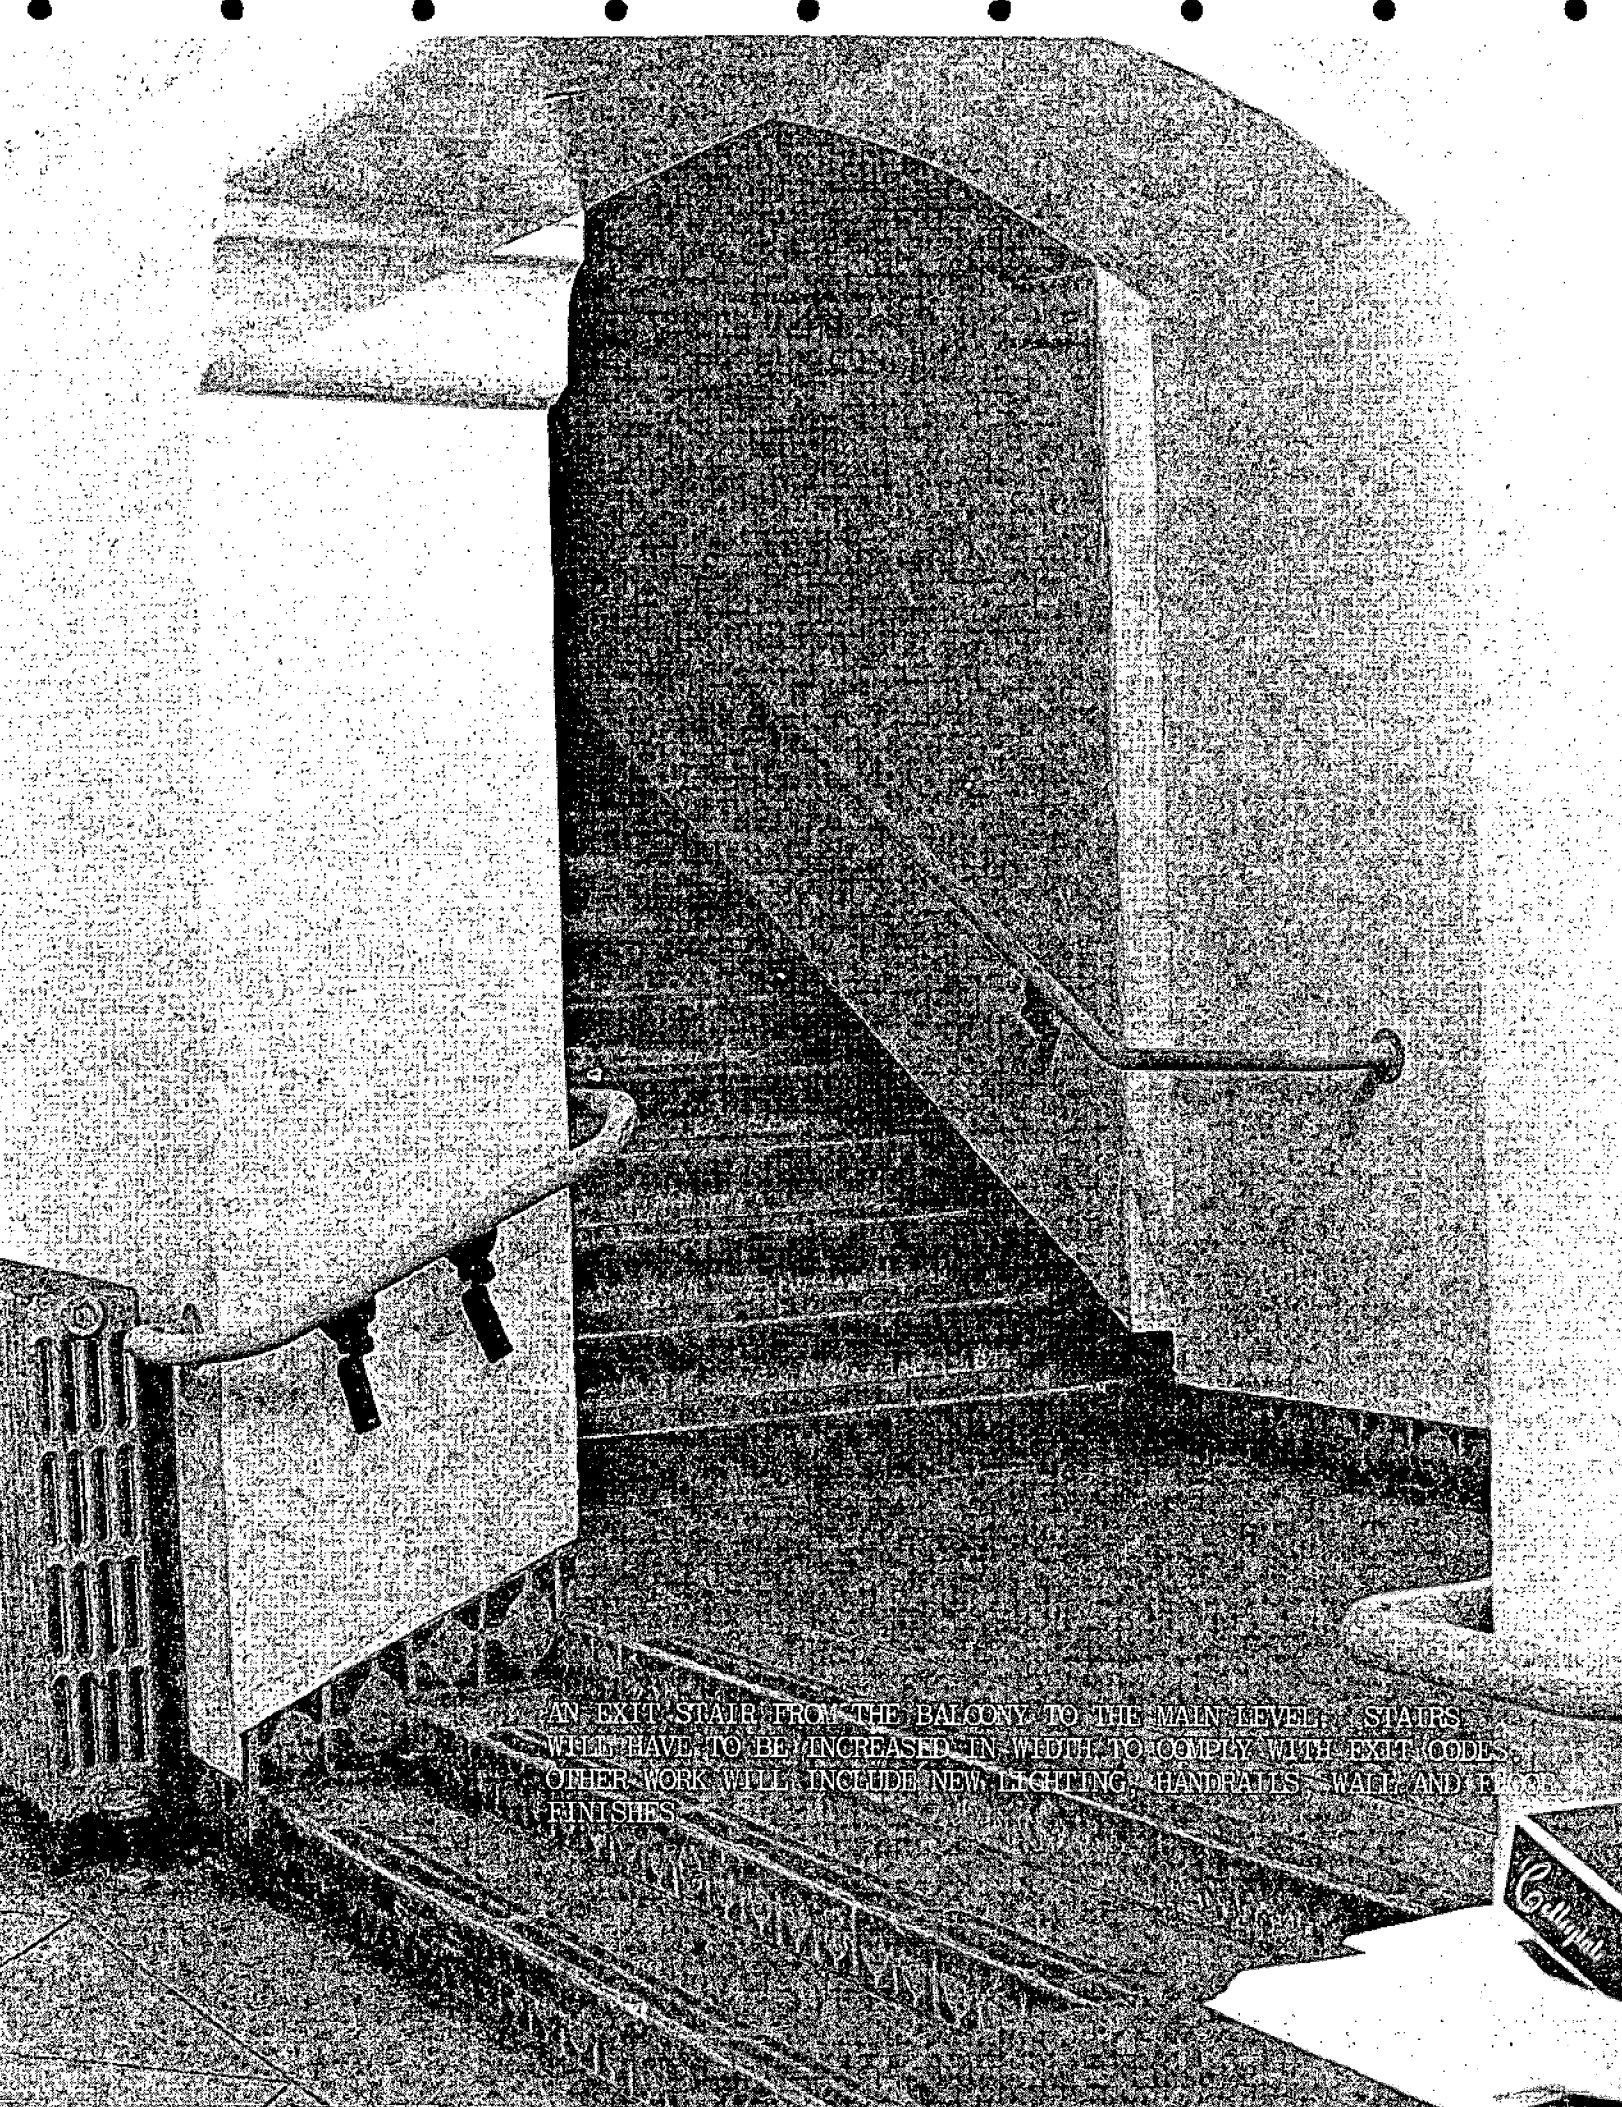
AN EXIT STAIR FROM THE BALCONY TO THE MAIN LEVEL. STAIRS
WILL HAVE TO BE INCREASED IN WIDTH TO COMPLY WITH EXISTING CODES.
OTHER WORK WILL INCLUDE NEW LIGHTING, HANDRAILS, WALL AND TRIM
FINISHES.

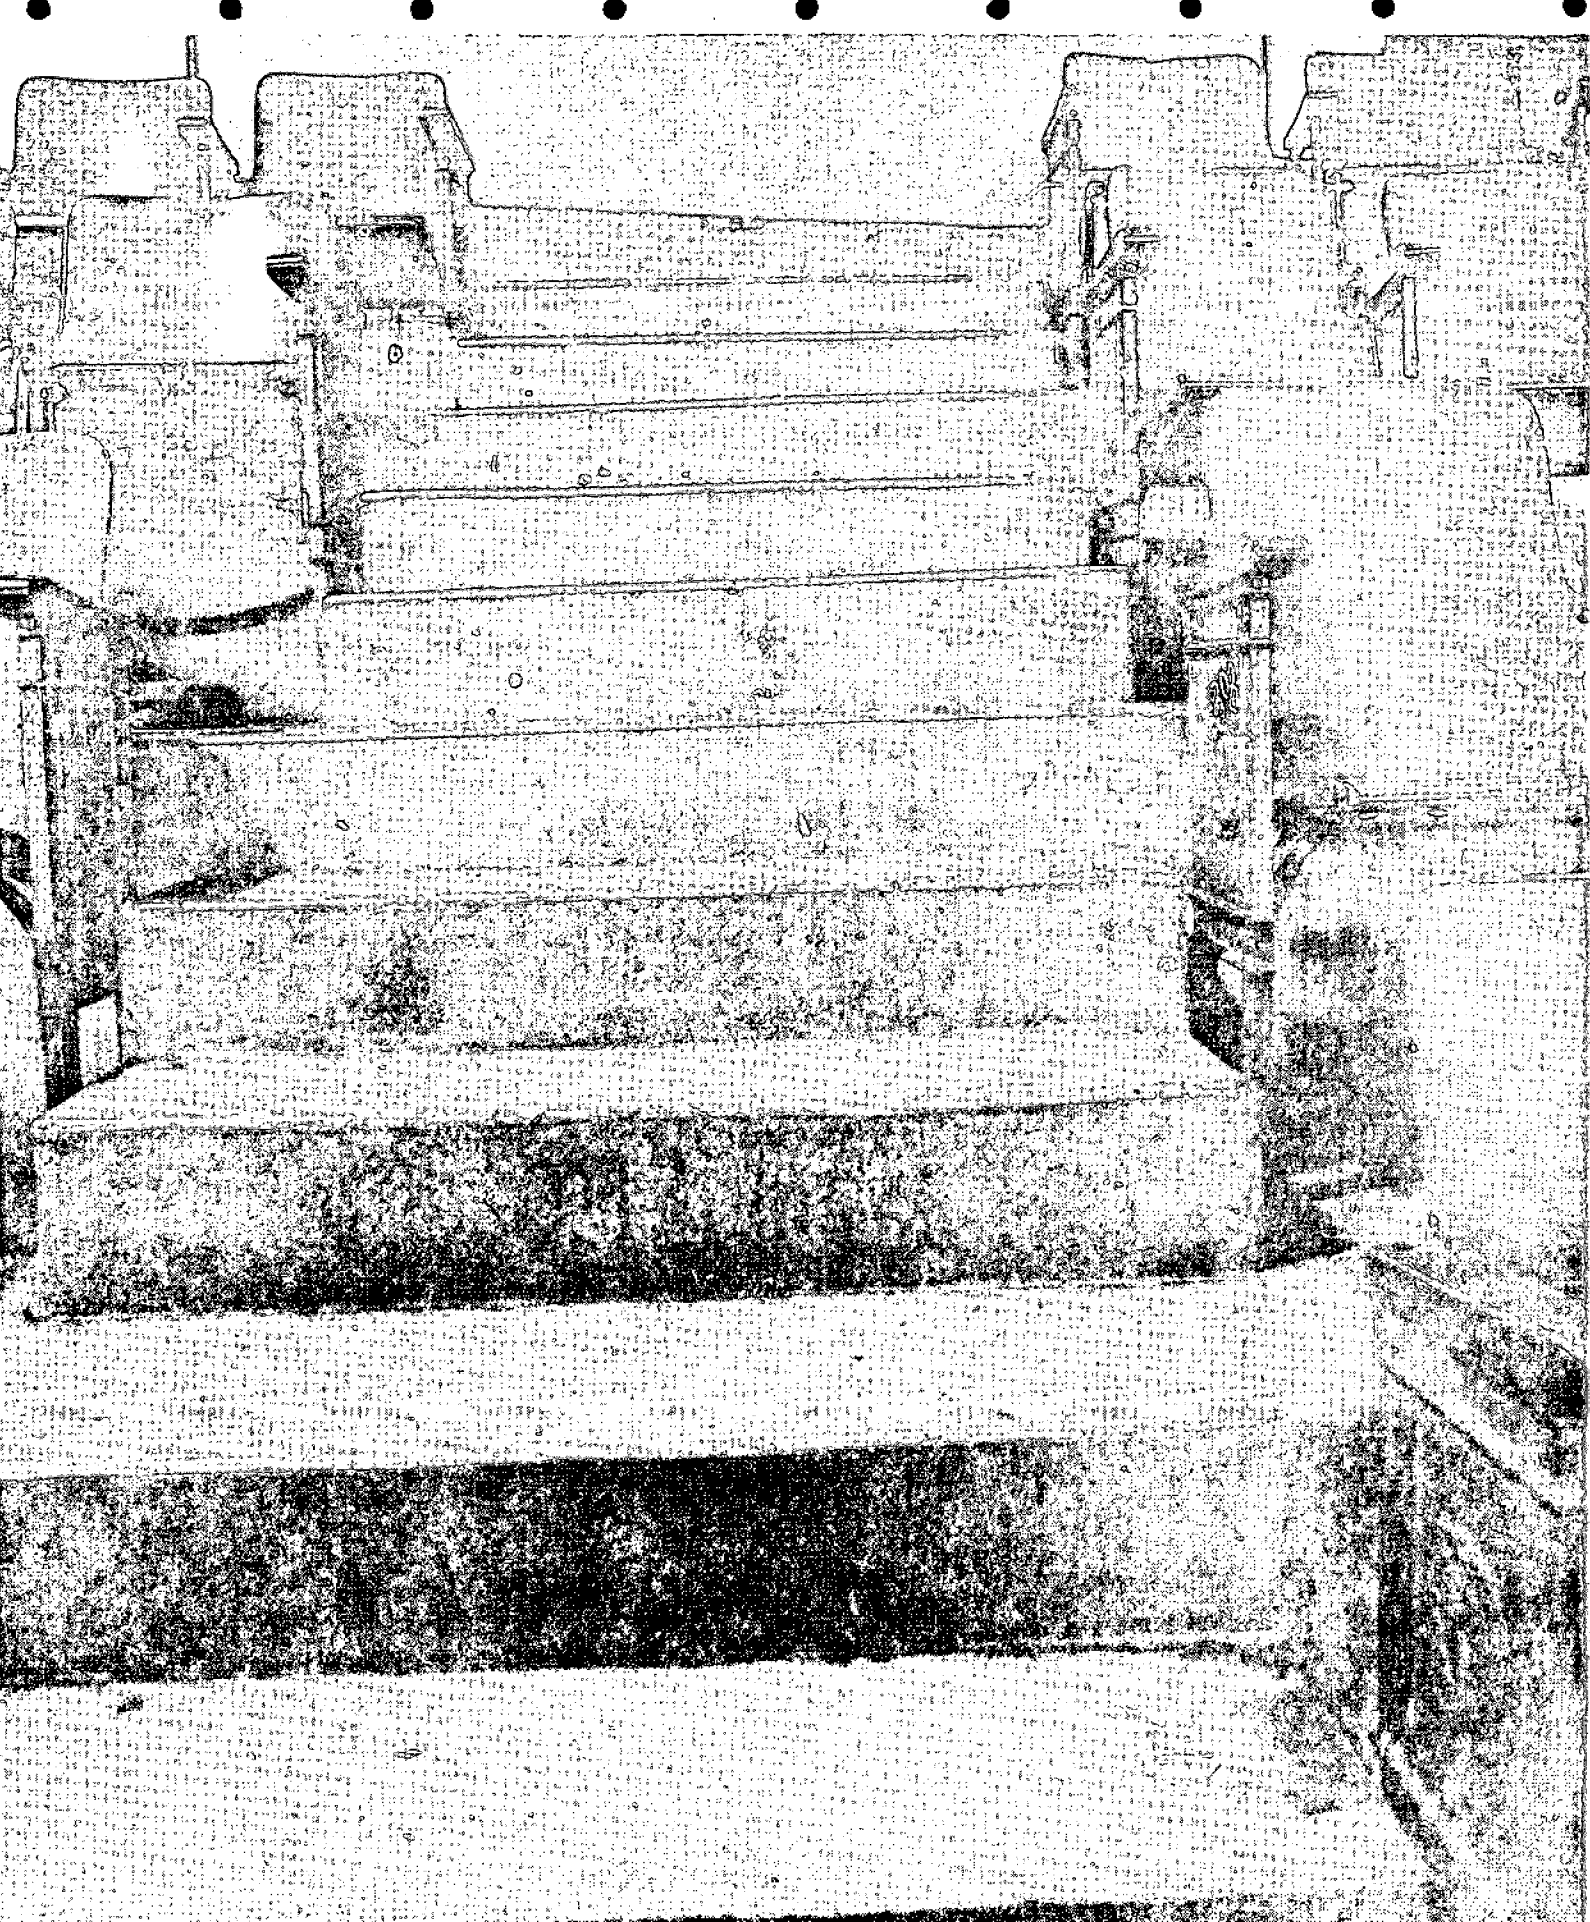
AN AISLE TO THE SEATS OF THE SECOND BALCONY. WORK WOULD INCLUDE THE REMOVAL OF THE AISLE LENGTH BEYOND TWENTY FEET, THE PROVISION OF AISLE LIGHTING AND HAND RAILS (BOTH INTEGRAL WITH THE NEW PROPOSED SEATS)

The aisles in the second balcony requires illumination. The steepness and lack of illumination on the aisles create a very hazardous situation.

We recommend the provision of two permanent follow-spot platforms and power receptacles placed at the auditorium's southeast and southwest corners in the balcony. These platforms can be located in the balcony seat rows which must be abandoned where the aisles exceed the 20 feet maximum deadend limit.

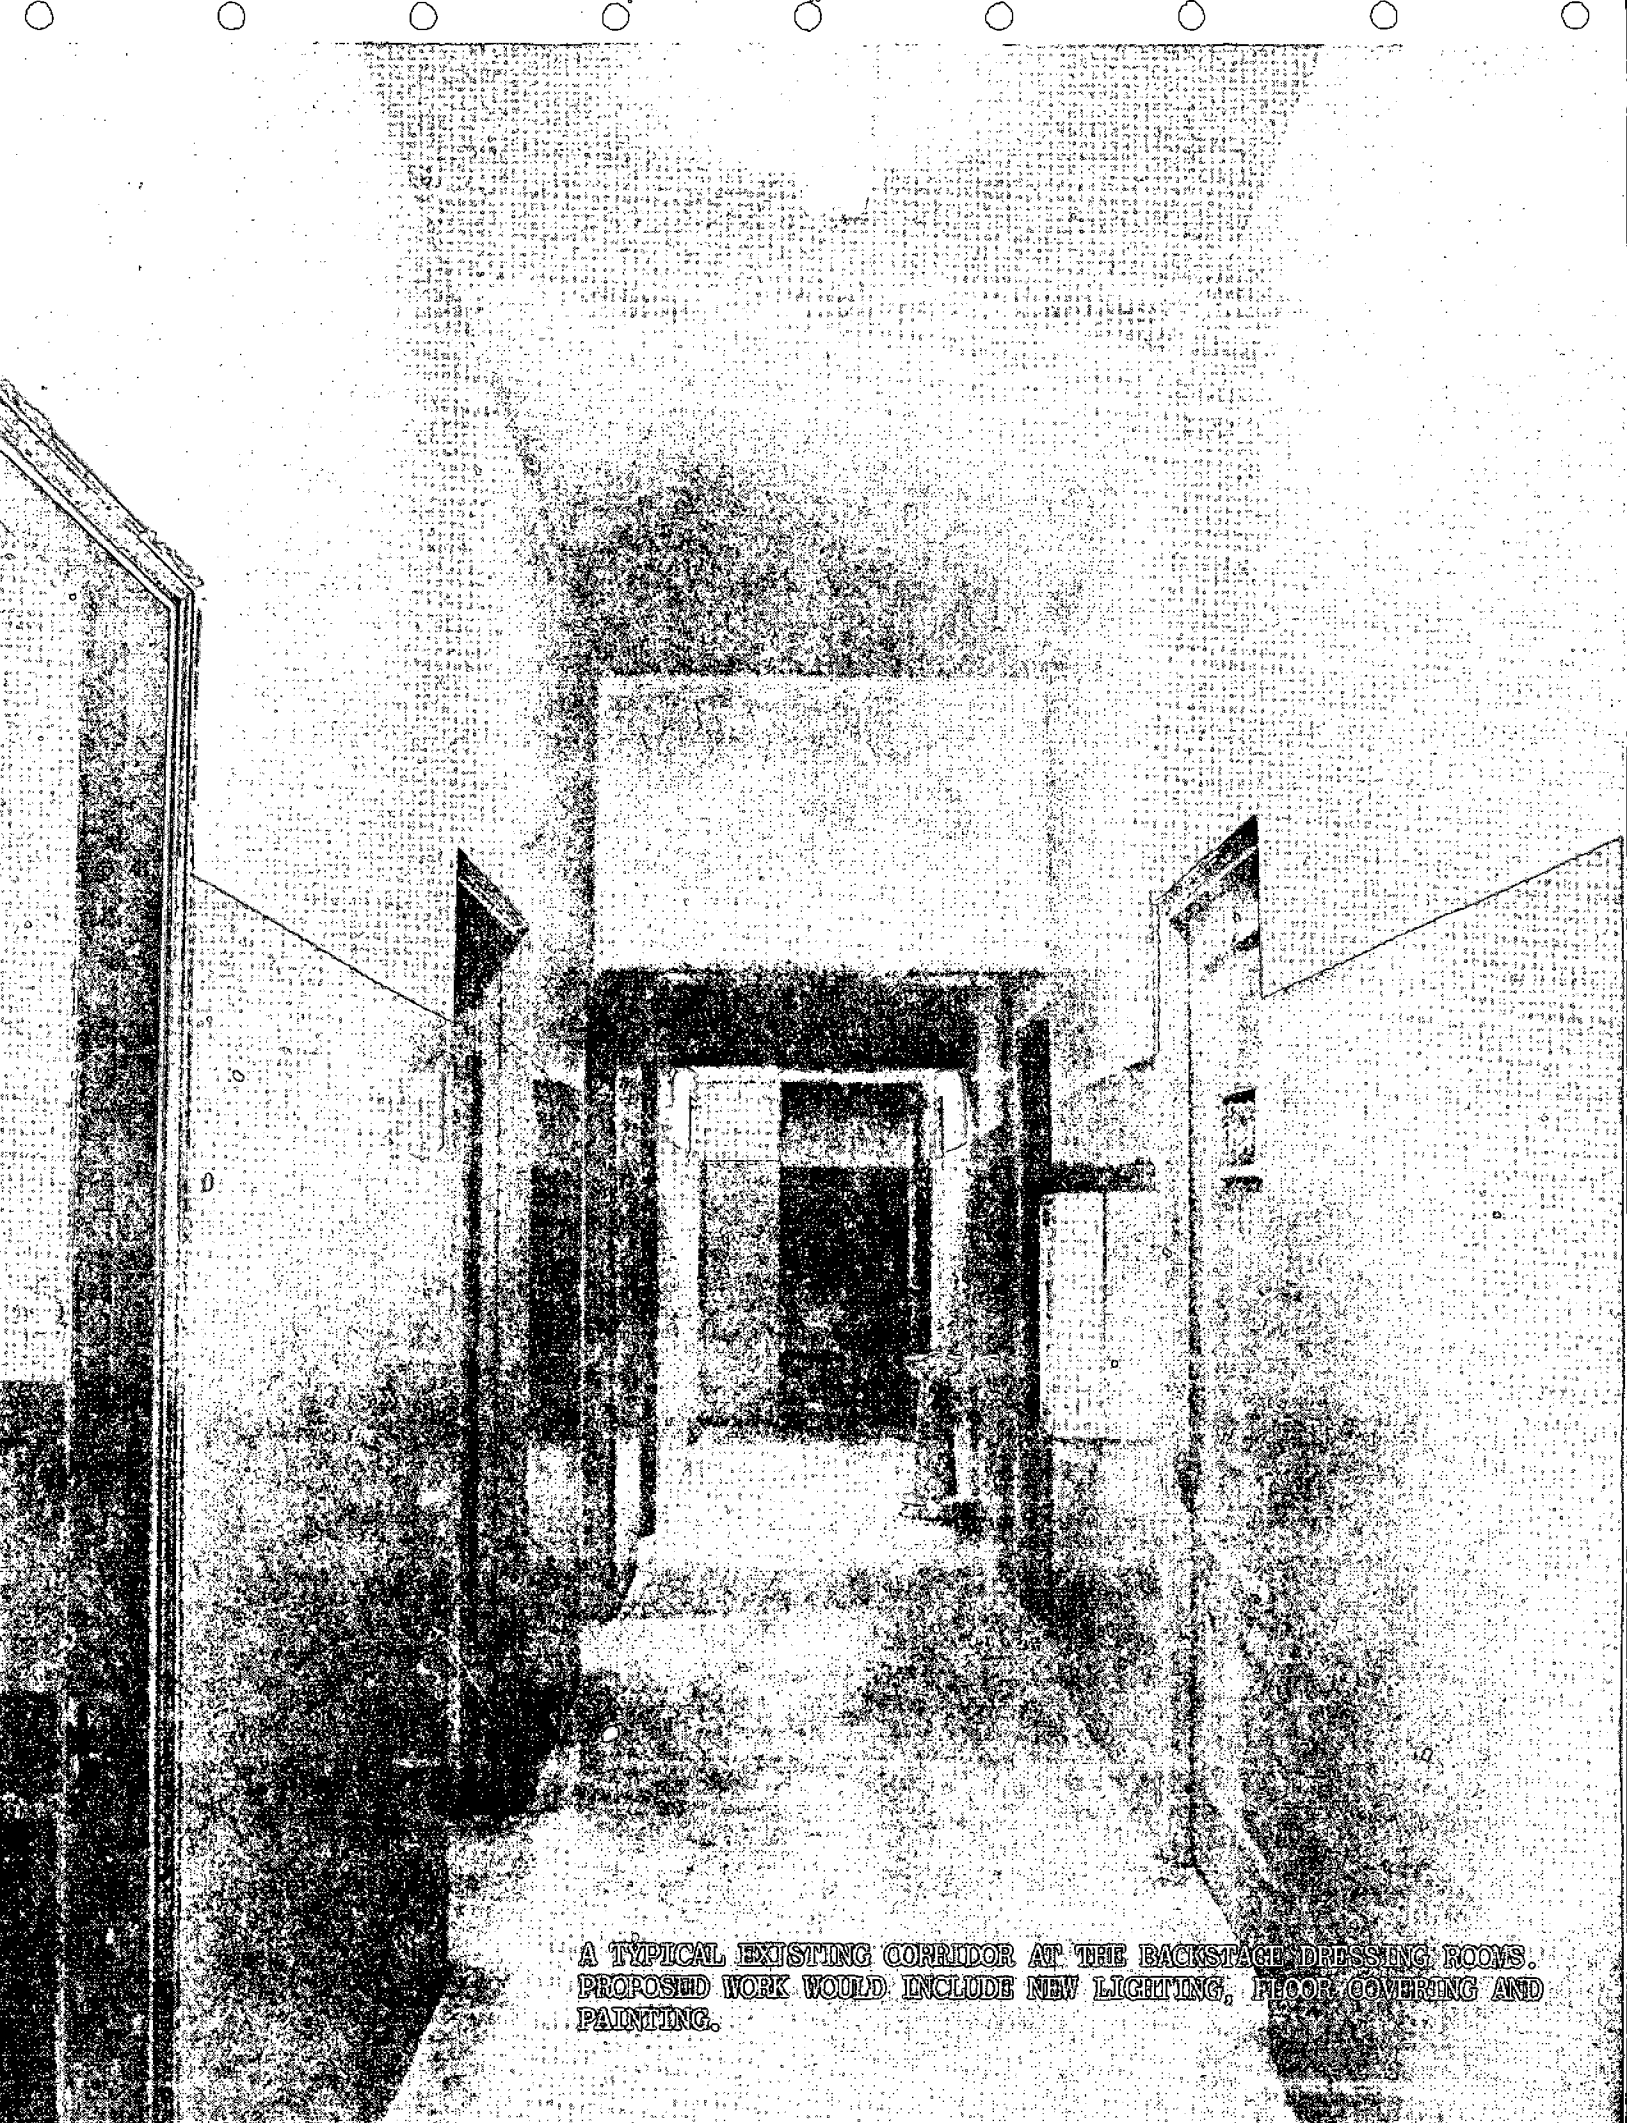
A TYPICAL EXISTING CORRIDOR AT THE BACKSTAGE DRESSING ROOMS. PROPOSED WORK WOULD INCLUDE NEW LIGHTING, FLOOR COVERING AND PAINTING.
