SUBJECT: MEMORIAL AUDITORIUM RENOVATION
Rehabilitation Program

**SACRAMENTO
MEMORIAL
AUDITORIUM**

**A
REHABILITATION
PROGRAM**

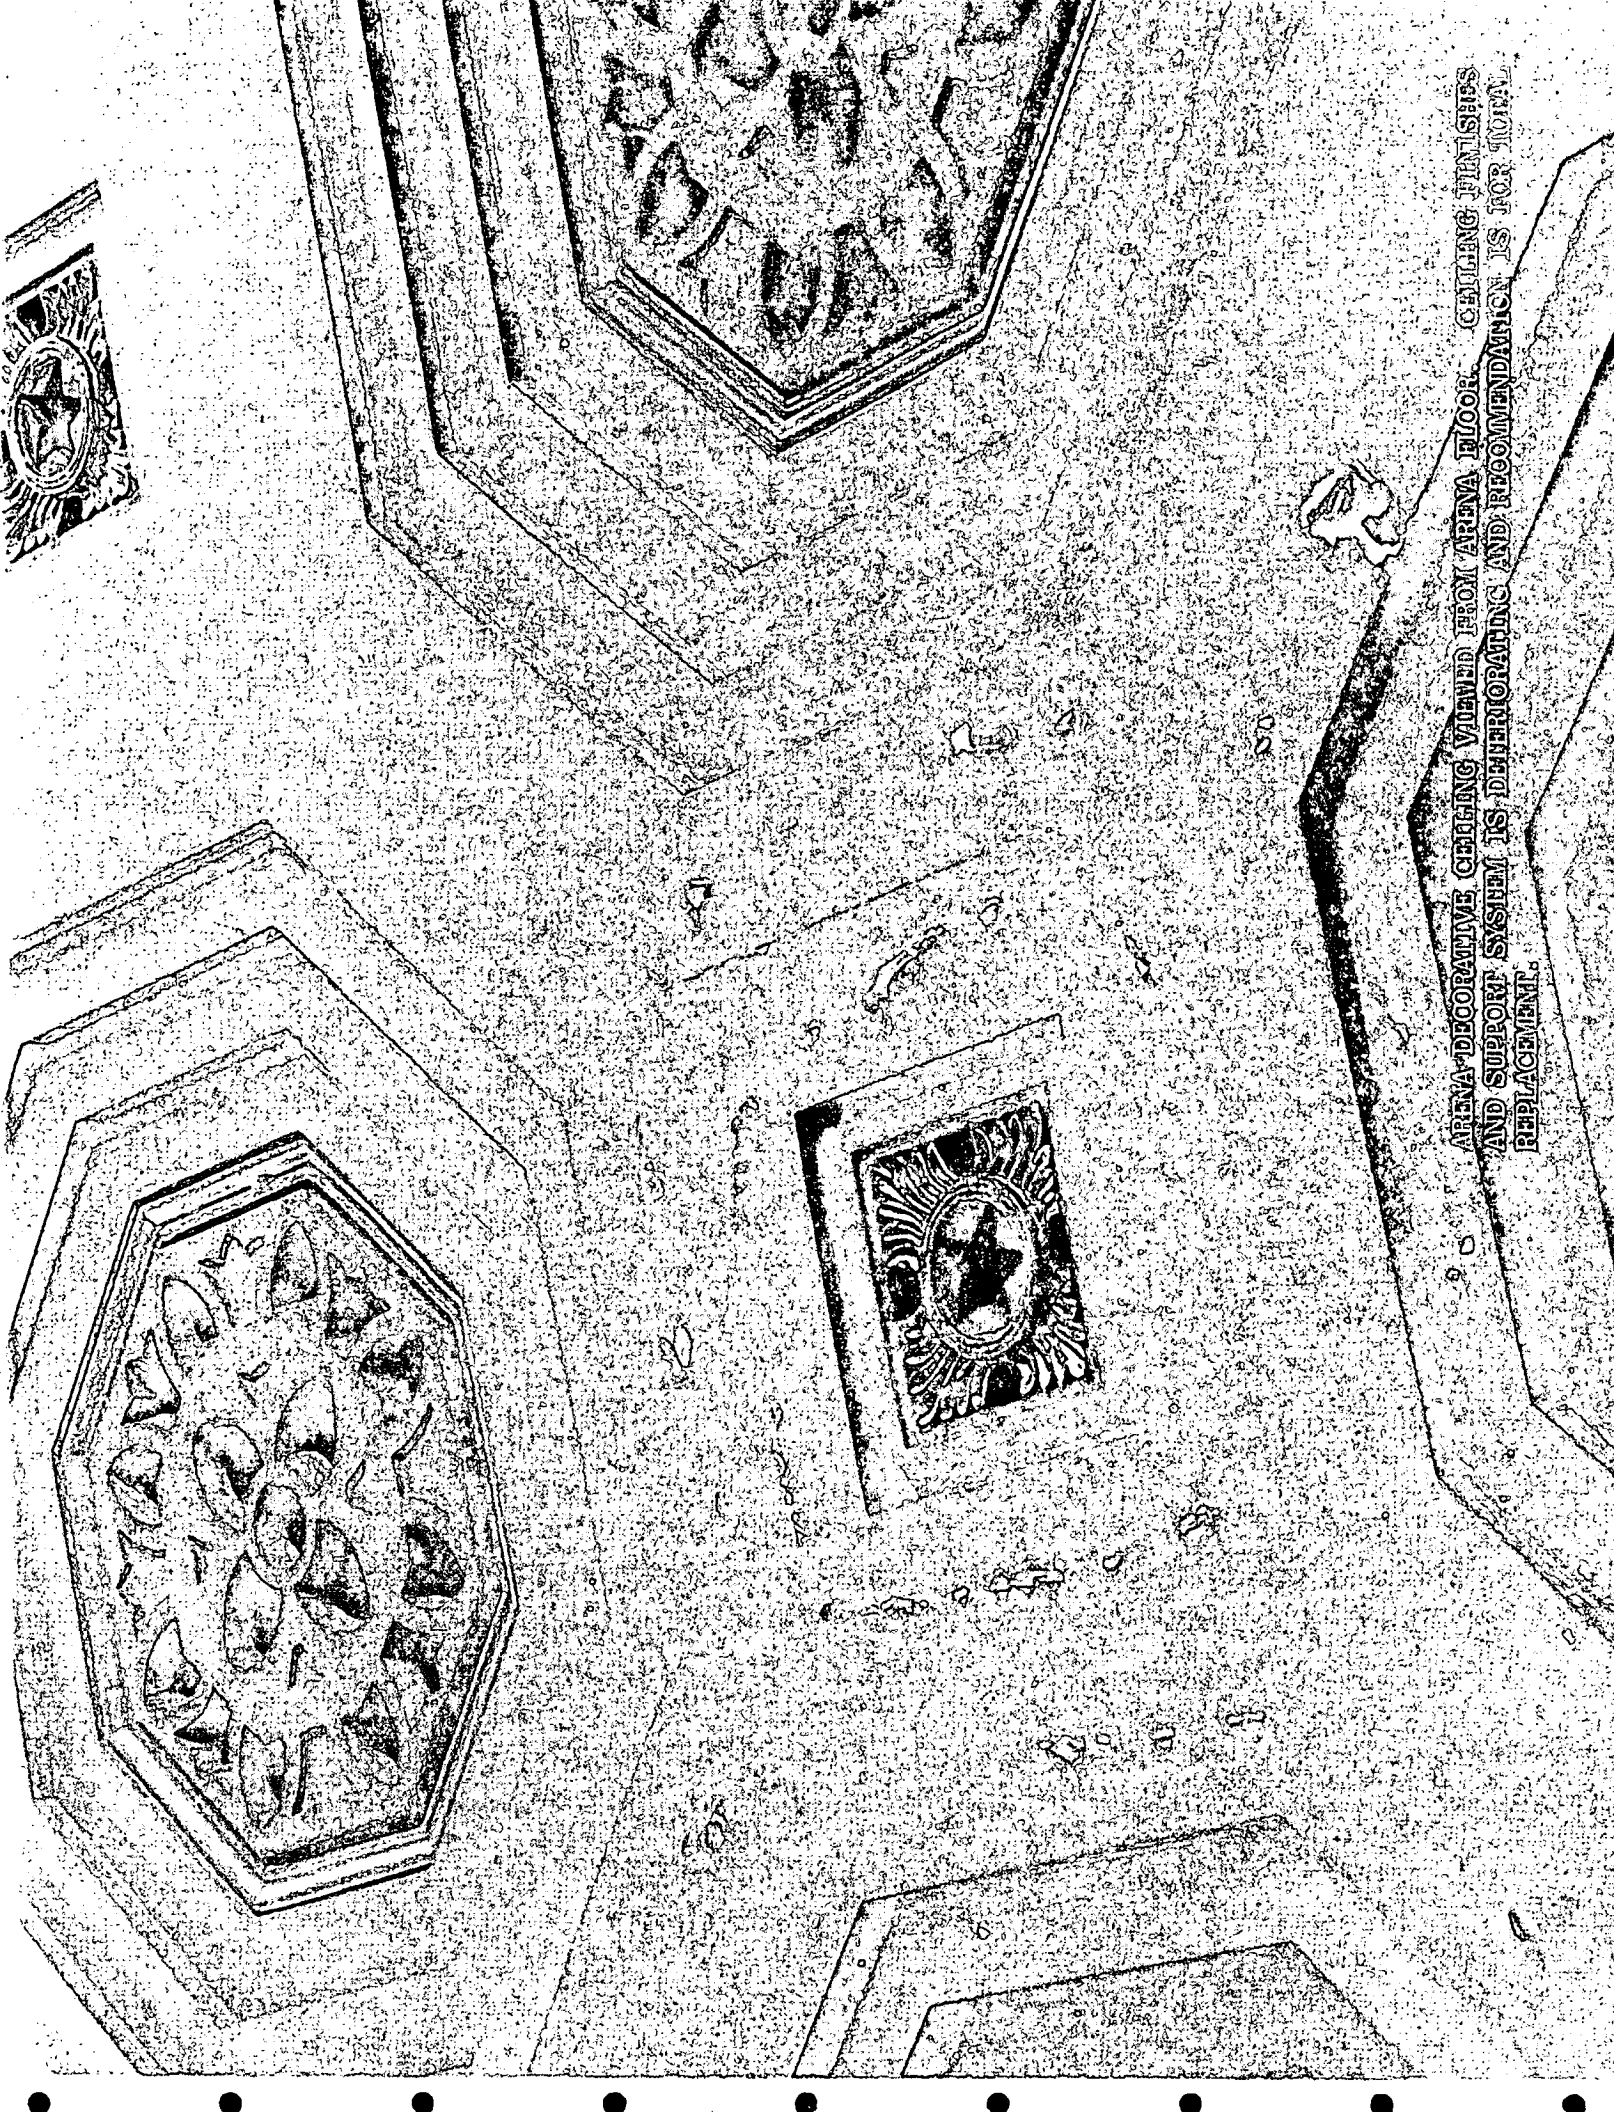
ARENA-DECORATIVE CEILING VIEWED FROM ARENA FLOOR. CEILING FINISHES AND SUPPORT SYSTEM IS DETERIORATING AND RECOMMENDATION IS FOR TOTAL REPLACEMENT.

Our review of the existing facility has brought to light this potentially hazardous condition. The ceiling is an ornate, suspended plaster which, due to extreme hard use (operations and road show personnel walking on and cutting holes through it for production events) and rock concerts (high decibel vibrations) have caused it to deteriorate to a point of possible failure.

- i. One: Leave the existing ceiling intact; reinforcing it with suspension wires set within the existing plaster using epoxy.
- ii. Two: Leave the existing ceiling intact; reinforce it using an epoxy injection procedure--spray the epoxy over the entire surface exposed in the attic.
- iii. Three: Remove the existing ceiling and replace it with an exact replica, also of plaster.
- iv. Four: Remove the existing ceiling and replace it with an exact replica in fiberglass.

Our recommendation is to use Alternative Four. The ceiling must be flexible enough to accommodate cut-outs for pre-set lights, winches, etc. To use Alternate Two would greatly reduce this required flexibility. Alternate One will not guarantee a safe ceiling structure. The existing plaster has deteriorated greatly and the epoxy suspension inserts are only as good as the surrounding plaster matrix. In effect, large

pieces of plaster could break away between the suspension inserts. Alternatives Three and Four are basically the same, but the Alternate Three system is heavy, cumbersome to erect and most importantly, susceptible to the same deterioration as in the existing ceiling.

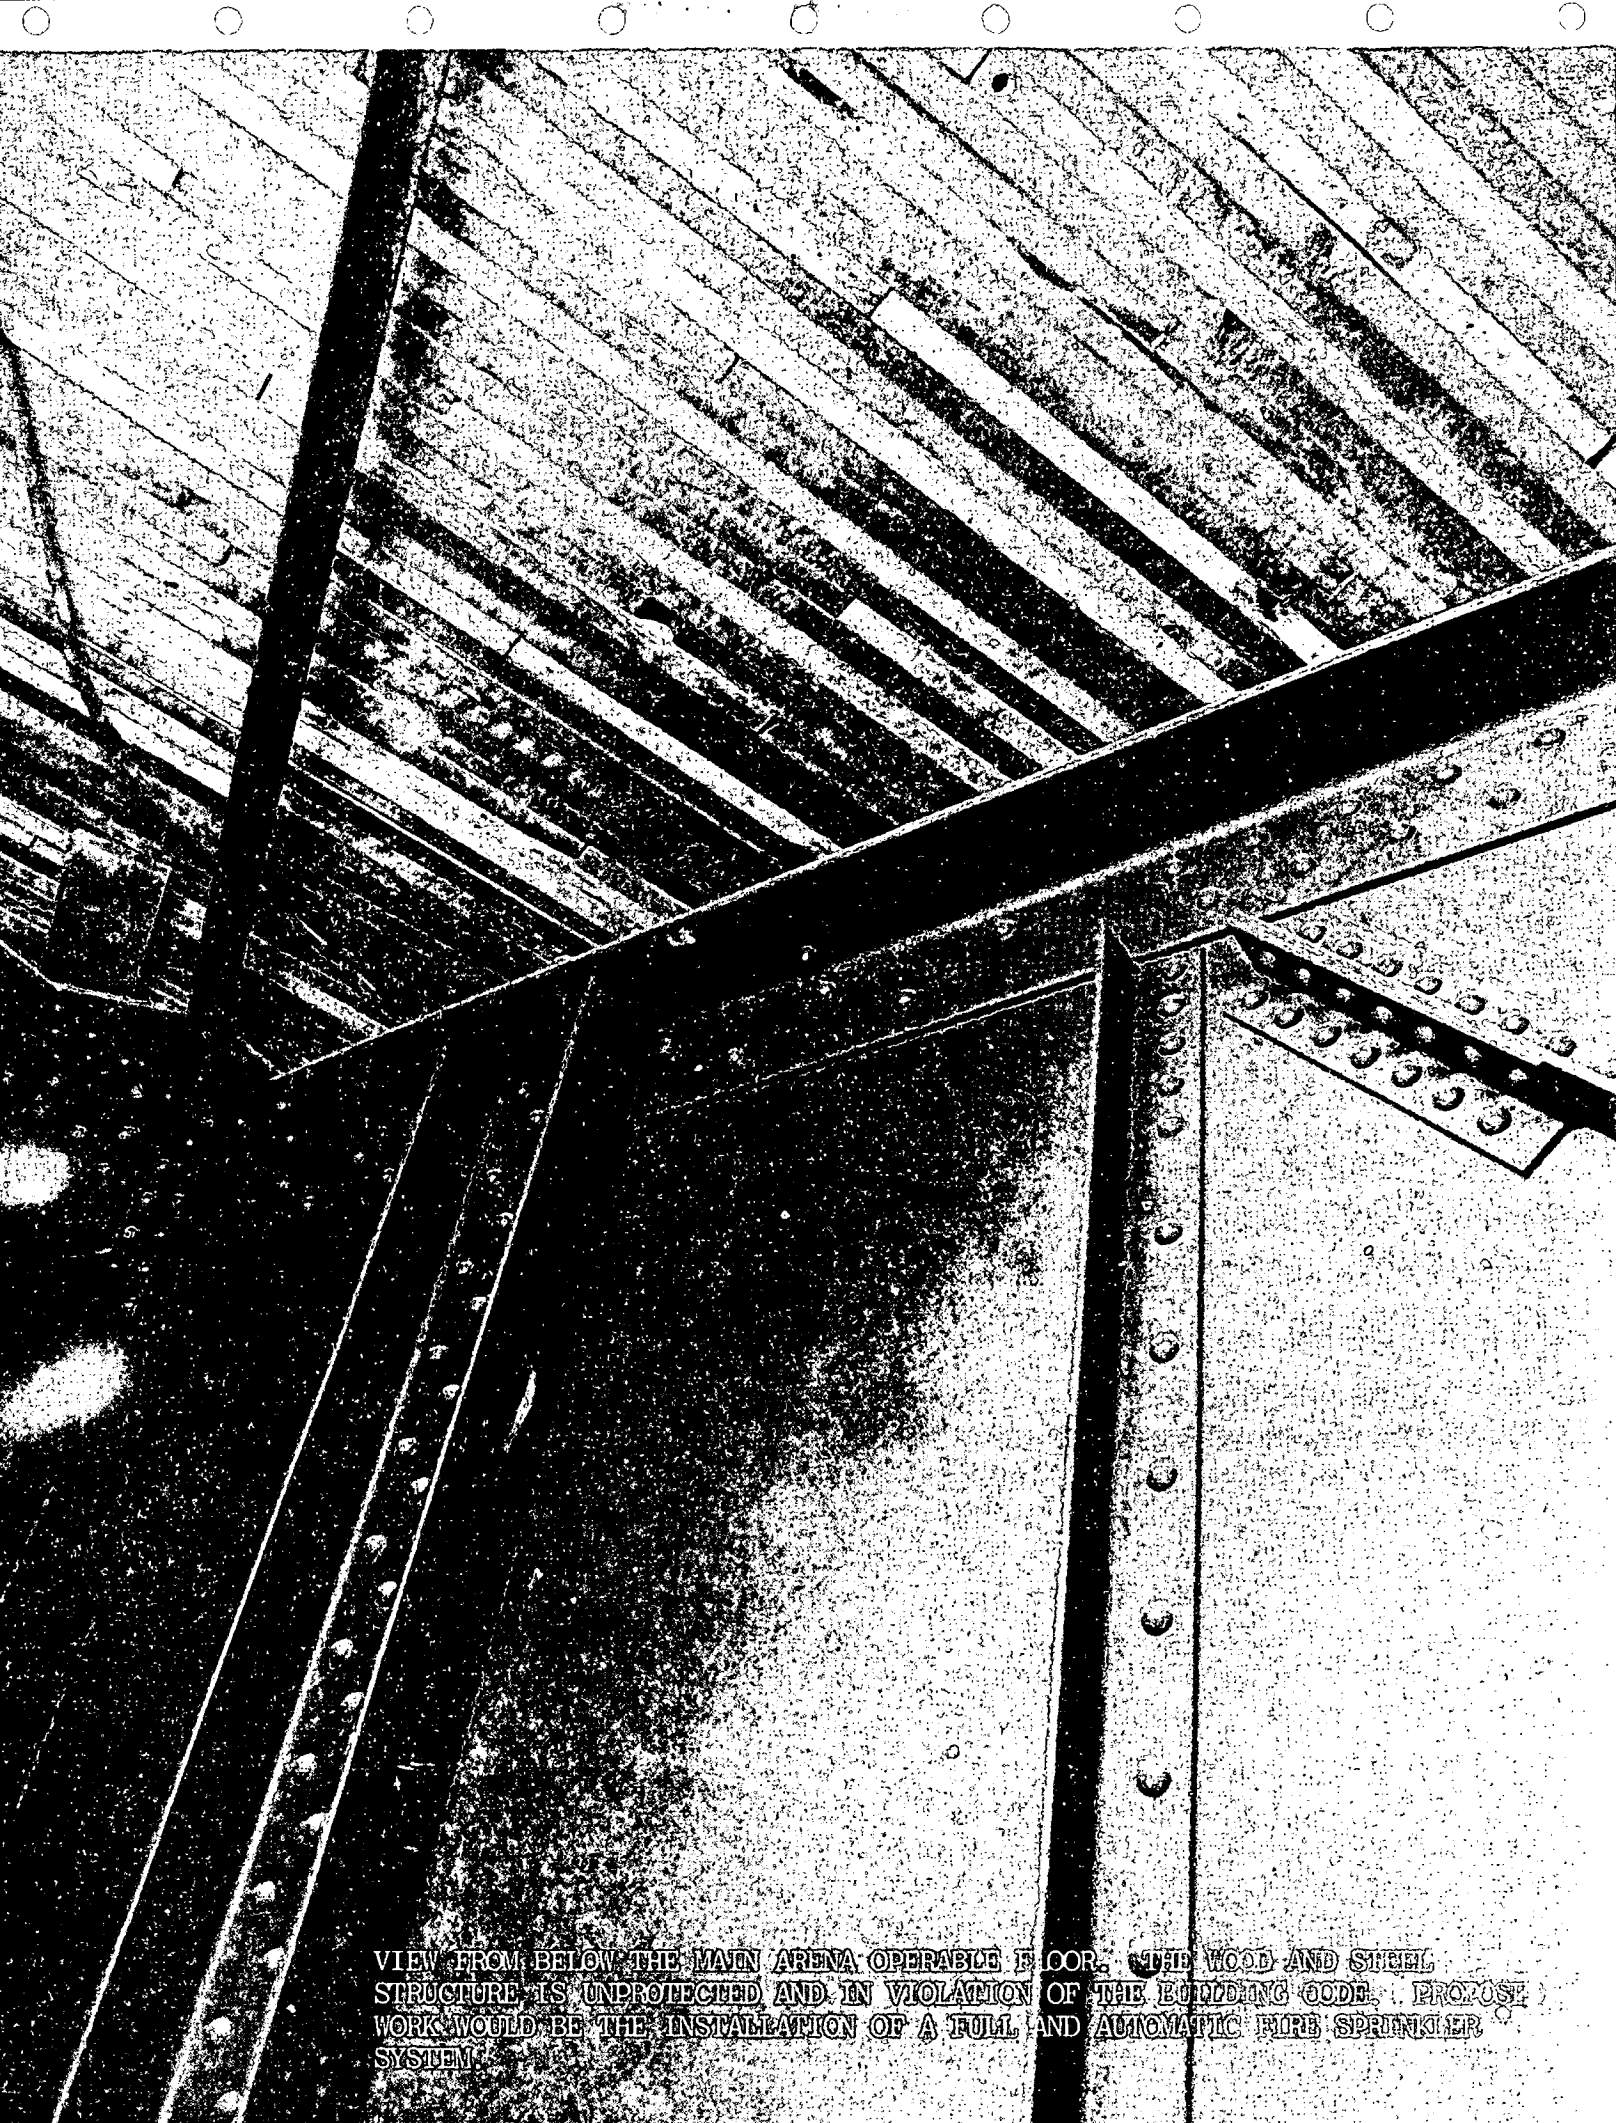
VIEW FROM BELOW THE MAIN ARENA OPERABLE FLOOR. THE WOOD AND STEEL STRUCTURE IS UNPROTECTED AND IN VIOLATION OF THE BUILDING CODE. PROPOSED WORK WOULD BE THE INSTALLATION OF A FULL AND AUTOMATIC FIRE SPRINKLER SYSTEM.

New fire sprinkler systems will be required for certain portions of the building, however, the installation of a new system for the entire building is recommended especially in view of the fact that trade-offs could be made for present building code deficiencies.

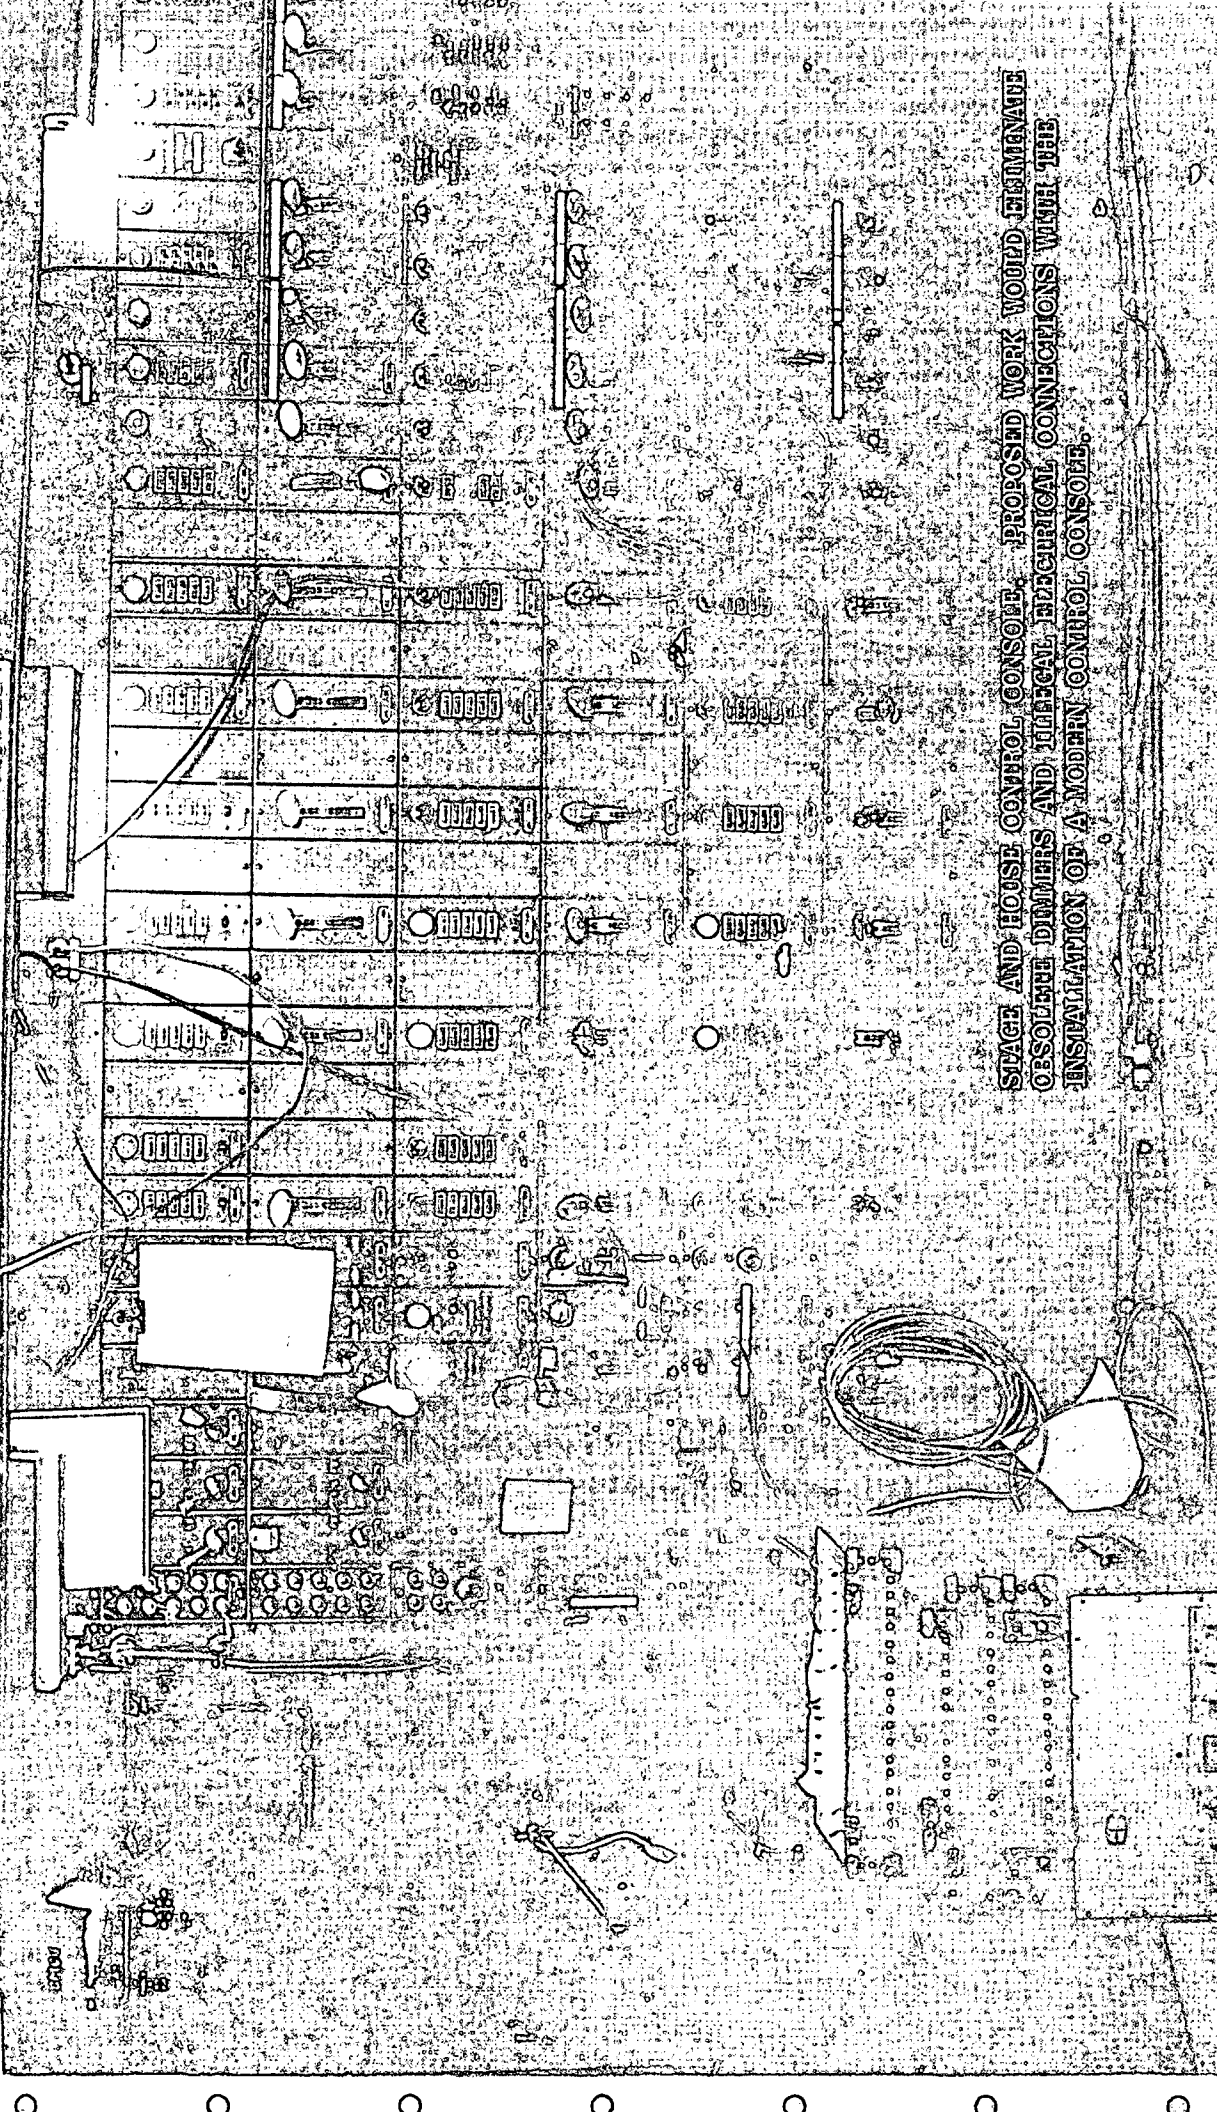
STAGE AND HOUSE CONTROL CONSOLE. PROPOSED WORK WOULD TERMINATE
OBSOLETE DIMMERS AND ELECTRICAL CONNECTIONS WITH THE
INSTALLATION OF A MODERN CONTROL CONSOLE.

- i. Replace draperies, including the fire curtain.
- ii. Provide front lighting for forestage and first entrance.
- iii. Replace dimmer board.

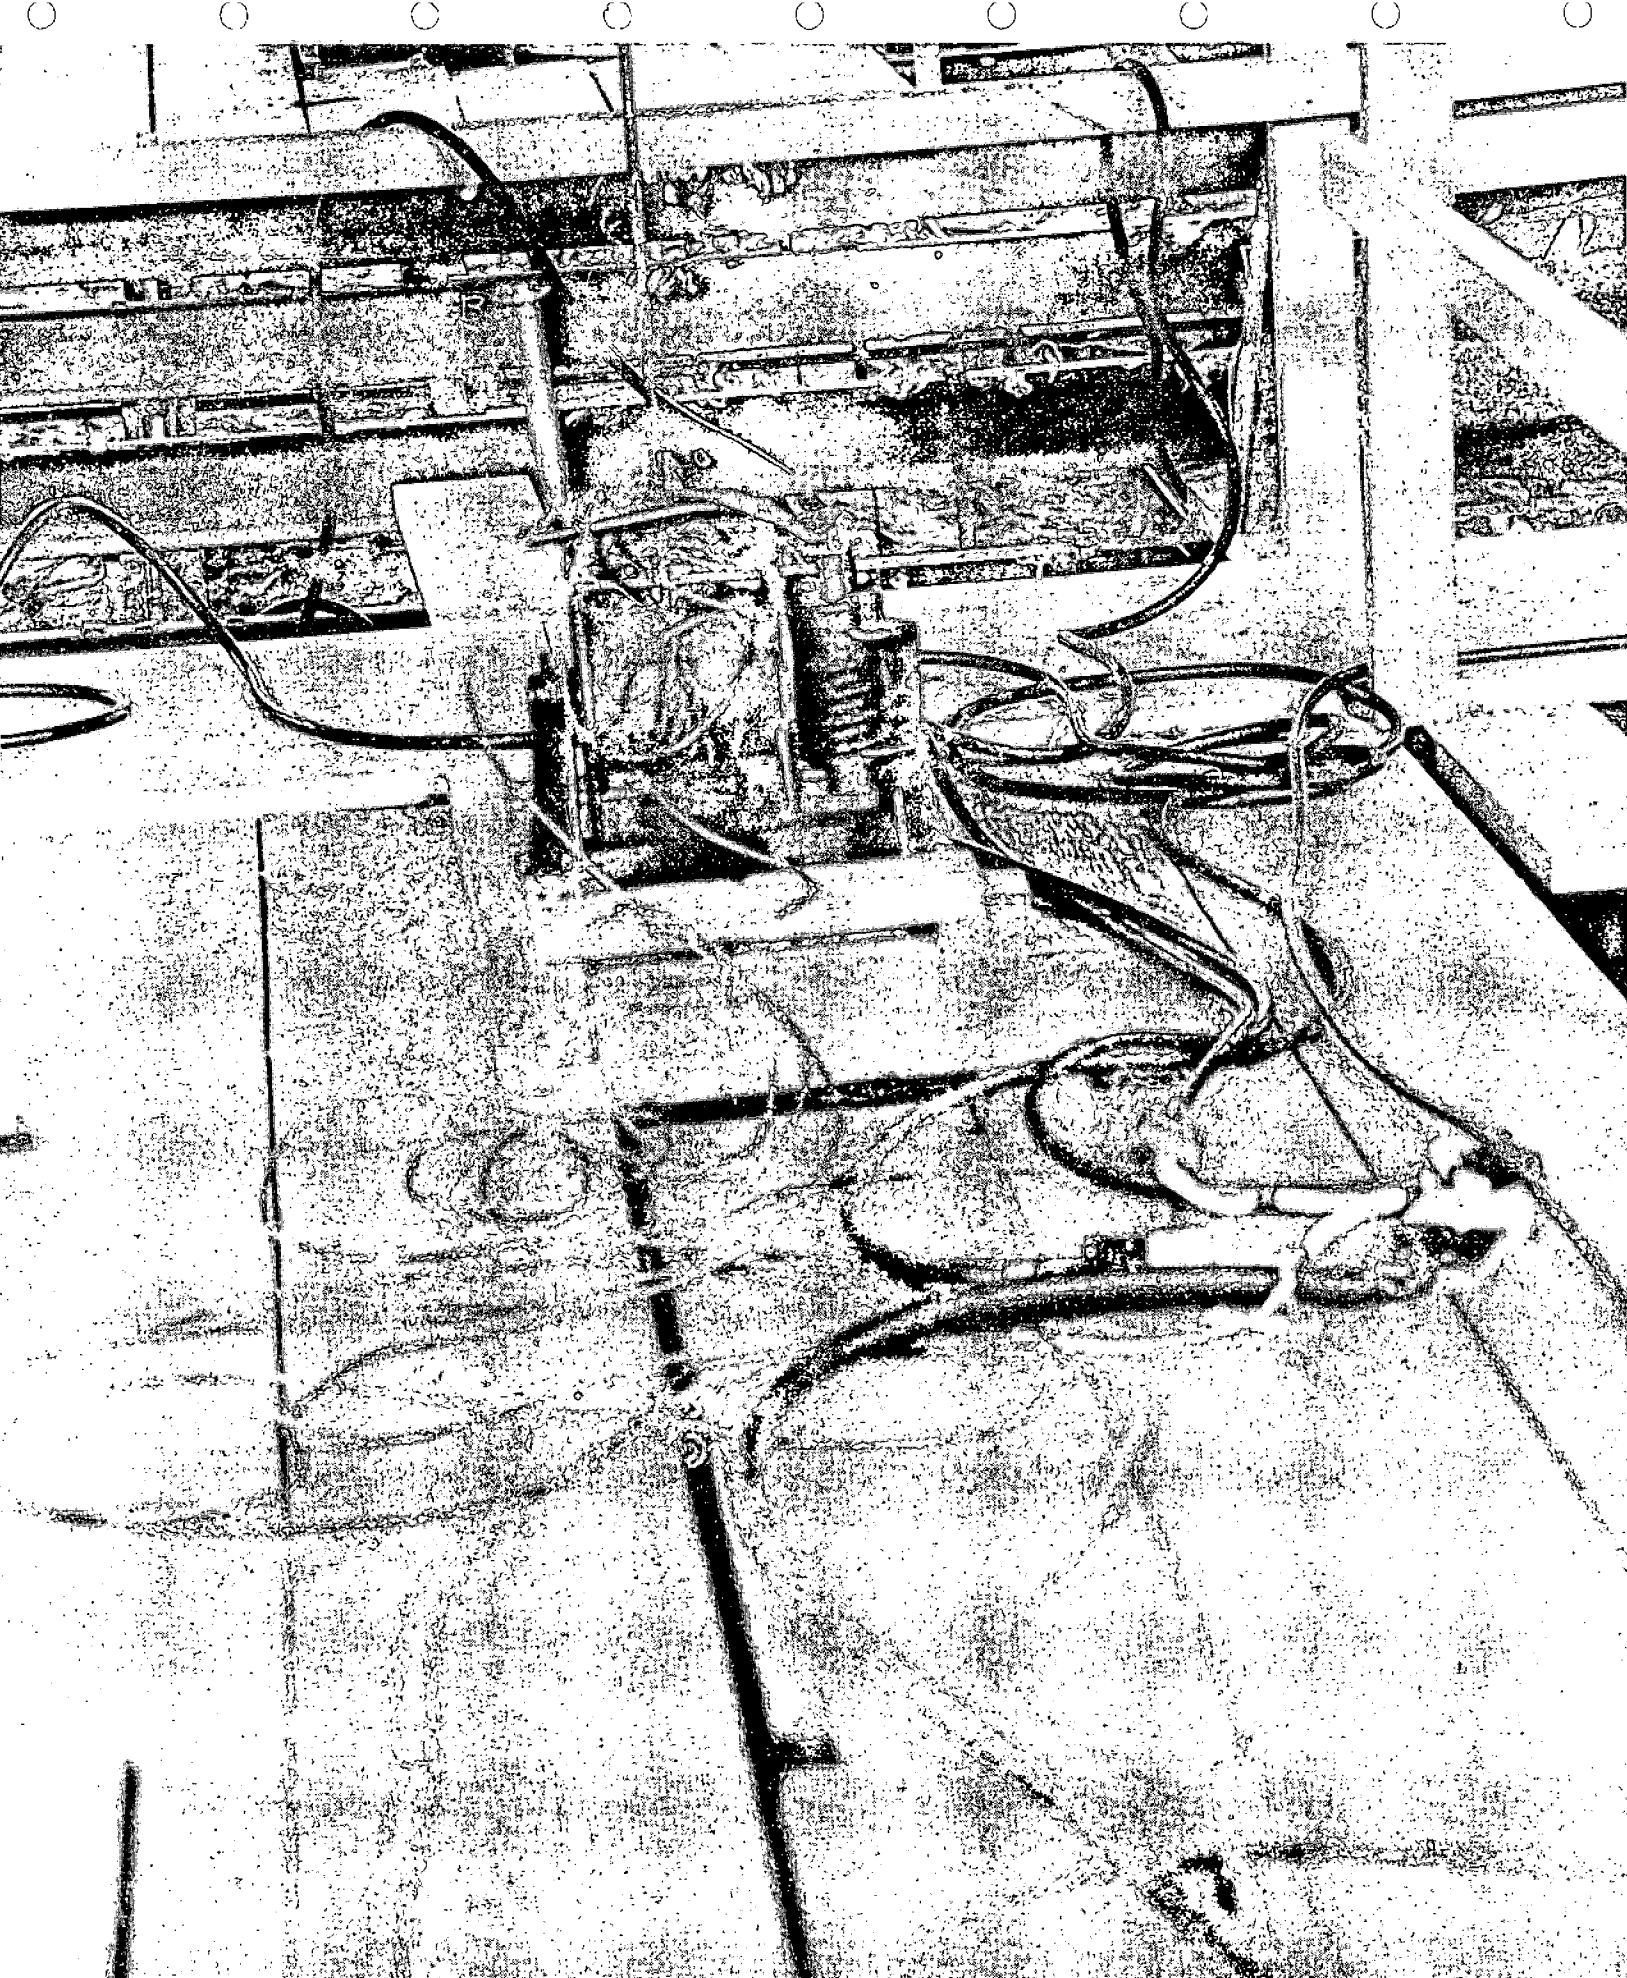
IMPROPER ELECTRICAL CONNECTIONS IN THE ATTIC OVER THE MAIN ARENA.
WORK HERE MUST INCLUDE THE TOTAL REDESIGN OF CONDUITS, RUNS, JUNCTION
BOXES AND LIGHT FIXTURE CONNECTIONS.

- Replace all existing, antiquated distribution and lighting panelboards.
- Relocate the distribution panel in the attic so as to be accessible by maintenance personnel.
