Site Address: 1565 35TH ST SAC
Parcel No: 007-0301-023

Nature of Work: DRY ROT AND STUCCO REPAIR

WOOD DESTROYING PESTS AND ORGANISMS INSPECTION REPORT

BUILDING NO 1565	STREET 35TH STREET	CITY SACRAMENTO	ZIP 95816	COUNTY CODE 34	DATE OF INSPECTION 04/25/2000	NUMBER OF PAGES 7
---------------------	-----------------------	--------------------	--------------	-------------------	----------------------------------	----------------------

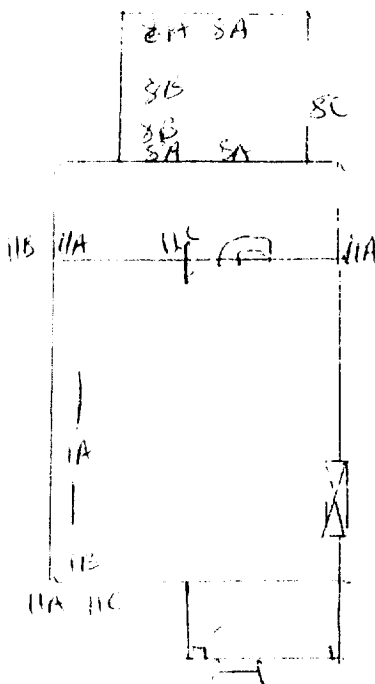
DIAGRAM AND EXPLANATION OF FINDINGS (This report is limited to structure or structures shown on diagram.)

FINDING 11A: Fungus infection and damage noted at roof eave sheathing. - **Section 1 Item**

FINDING 11B: Fungus infection and damage noted at barge rafter. - **Section 1 Item**

FINDING 11C: Fungus infection and damage noted at access port and vent molding. - **Section 1 Item**

FINDING 1A: Evidence of subterranean termite infestation and damage noted at rim joist. Infestation and damage appear to extend into inaccessible area behind stucco. - **Section 1 Item**

FINDING 1B: Evidence of wood boring beetle infestation noted at rim joist. Infestation appears to extend into inaccessible area behind stucco. - **Section 1 Item, - Unknown, Further Inspection**

FINDING 1C: Plumbing waste line is noted to be cracked.

FINDING 8A: Evidence of subterranean termite infestation and damage noted at sheathing. - **Section 1 Item**

FINDING 8B: Excessive moisture, fungus infection, and damaged noted at wall plate and sheathing. Moisture appears to be caused by faulty grade condition. - **Section 1 Item**

FINDING 8C: Fungus infection and damage noted at wall plate and base of door jamb. - **Section 1 Item**

RECOMMENDATION 11A-1: Remove and replace damaged sheathing.

RECOMMENDATION 11A-2: After repairs have been completed, Owner will need to consult a licensed roofing contractor to repair roof covering.

RECOMMENDATION 11B: Remove and replace damaged barge rafter.

RECOMMENDATION 11C: Remove and replace damaged molding.

RECOMMENDATION 1A-1: Remove stucco as necessary to make area accessible for inspection. A Supplemental Inspection will be made and Report issued outlining our findings, recommendations and any additional cost.

RECOMMENDATION 1A-2: Chemically treat all exterior and interior perimeters of the structure with the registered termiticide, Premise (Imidacloprid). Drill and treat areas where there is concrete. Seal the drill holes. Western Exterminator Company will not be responsible for damage to or repair of floor covering, hidden pipes, conduits, or ducts or their repair.

RECOMMENDATION 1B: Refer to Recommendation Item 1A-1 for correction.

RECOMMENDATION 1C: Owner to consult a licensed plumber for further inspection and recommendation for repair.

RECOMMENDATION 8A-1: Refer to Recommendation Item 1A-1 for correction.

RECOMMENDATION 8A-2: Refer to Recommendation Item 8B below for correction.

RECOMMENDATION 8B: Cut off wall studding and remove the sill. Install a new sill and approximately forty (40) lineal feet of above grade foundation.

RECOMMENDATION 8C: Cut off base and install masonry footing.

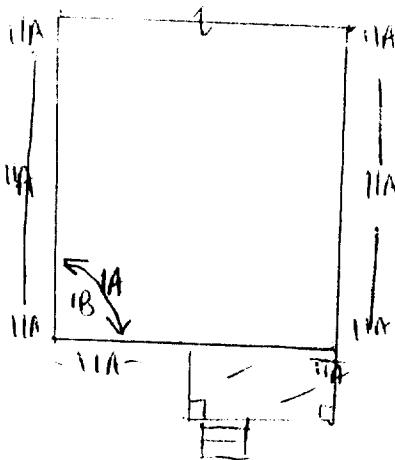
DIAGRAM AND EXPLANATION OF FINDINGS (This report is limited to structure or structures shown on diagram.)

ITEM NO. 1A (Section 1)
FINDING: Fungus infection and damage noted at rim joist, wall sheathing subfloor and wall plate.

ITEM NO. 1B (Section 1)
FINDING: Evidence of wood boring beetle infestation and damage noted at wall sheathing and wall plate.

ITEM NO. 11A (Section 1)
FINDING: Fungus infection and damage noted at roof eave sheathing.

RECOMMENDATION: Remove and replace or reinforce damaged wood members and and refinish to a reasonable match of existing material.

RECOMMENDATION: Refer to Recommendation Item 1A for correction.

TREAT ADJACENT WOOD MEMBERS WITH THE REGISTERED INSECTICIDE TIMBOR.

RECOMMENDATION: 1 Remove and replace damaged sheathing.

RECOMMENDATION: 2 After repairs have been completed, Owner will need to consult a licensed roofing contractor to repair roof covering.
