Site Address: 2158 56TH AV SAC

Nature of Work: REPLACE SHOWER PAN, REPLACE PORCH HEADER (REAR PORCH)

WOOD DESTROYING PESTS AND ORGANISMS INSPECTION REPORT

BUILDING NO. 2158	STREET 56TH AVENUE	CITY SACRAMENTO	ZIP 95822	COUNTY CODE 34	DATE OF INSPECTION 08/08/01	NUMBER OF PAGES 4
----------------------	-----------------------	--------------------	--------------	-------------------	--------------------------------	----------------------

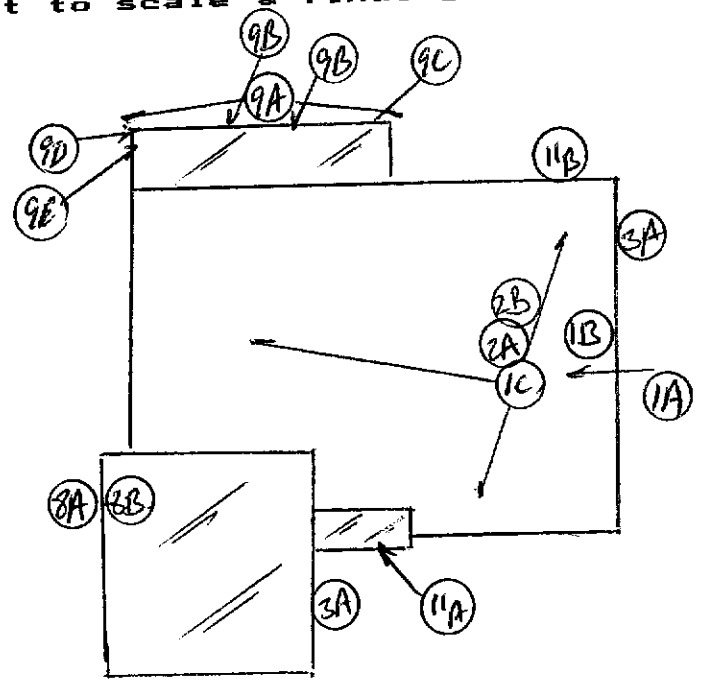
DIAGRAM AND EXPLANATION OF FINDINGS (This report is limited to structure or structures shown on diagram)

Item 1A: A faulty grade was noted at the subarea access. Lower soil to correct this condition.

Item 1B: Fungus infection and damage was found to the 2x6 T&G subfloor below the master bath. --- in the subarea, cut out damaged portion of subfloor and replace with new material. During the course of repairs, if damage is found to extend up into inaccessible areas, such will be outlined on a supplemental report.

Item 1C: A large portion of the substructure was found to be inaccessible for inspection due to insufficient clearance beneath the plumbing pipes and/or girder. Install trenches to allow for further inspection. Upon further inspection, issue a supplemental report with findings and a price quote for necessary repairs.

Item 2A: Minor grout deterioration was noted within the stall shower. Regrout as necessary.

Item 2B: The escusions were found to be loose within the stall shower. Owner or interested parties are directed other trades for correction.

Item 3A: Earth to wood contacts were noted at the base of the exterior siding marked 3A on diagram. Lower soil to correct this condition.

Item 8A: Water damage was noted to the side entrance door to the garage. Remove and replace side entrance door with one of similar design and style. An exact match of existing cannot be guaranteed. Reuse existing hardware.

Item 8B: Water stains and water damage was noted to the sheetrock within the interior of the garage. Owner or interested parties are directed to other trades for further evaluation of roof coverings, rain gutters, downspouts, and replacement of the sheetrock.

Item 9A: Fungus infection and damage was found to the 1x6 V-rustic roof sheathing. Remove and replace approximately 28 lineal feet of 1x8 V-rustic roof sheathing. Bid does not include reroofing disturbed area.

Item 9B: Fungus infection and damage was found to 2 2x4 rafters. Remove and replace damaged rafters with new material.

Item 9C: Fungus infection and damage was found to the fascia board. Remove and replace damaged fascia board with new material. NOTE: During the course of repairs it will be necessary to remove the rain gutter to facilitate the repairs to the fascia board. Bid does not include reinstalling rain gutter. Owner or interested parties are directed to other trades to reinstall rain gutter.

Item 9D: Fungus infection and damage was found to the 4x6 header beam. Remove approximately 10 lineal feet of the header beam and replace with new material.

Item 9E: Fungus infection and damage was found to the barge rafter. Remove and replace damaged portion of barge rafter to correct this condition.

Item 10A: Fungus infection and damage was found to the base shelf beneath the master bath and hall bath sink. No visible leaks were noted at this time. Other have repaired portions of the sheetrock adjacent to this area. ZAP Termite and Pest Control does not guarantee work performed by others. Remove and replace damaged portion of base shelf with new material. During the course of repairs, if damage is found to extend into inaccessible areas such will be outlined on a supplemental report.

Item 11A: Fungus infection and damage was found to the 2x4 rafter. Remove and replace damaged 2x4 rafter with new material.

Item 11B: Minor fungus infection and damage was found to the bottom row of siding, marked 11B on diagram. Remove and replace damaged bottom row of siding with new material.

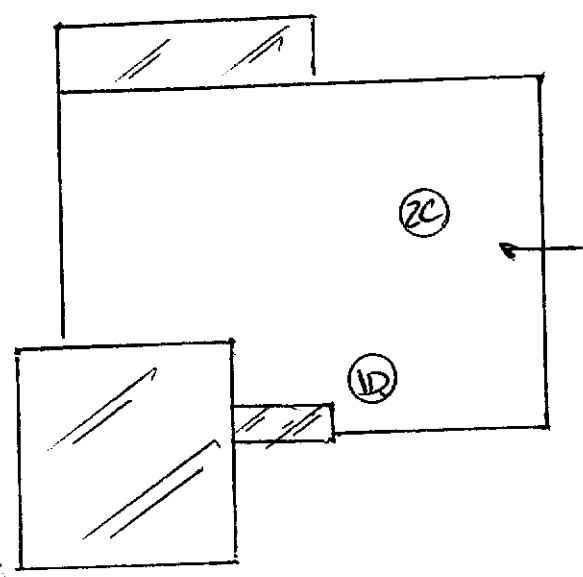
DIAGRAM AND EXPLANATION OF FINDINGS (This report is limited to structure or structures shown on diagram)

Item 1D: As outlined in item 1C, further inspection was performed within the subarea. Fungus infection and damage was found to the subfloor rimjoist beneath the bathtub of the hall bath. An attempt will be made to remove this damage from within the subarea. Remove and replace fungus damaged subfloor rimjoist with new material. During the course of repairs, if it becomes necessary to repair the damage on the topside, such will be outlined on a supplemental report. If damage is noted to extend into inaccessible areas, such will be outlined on a supplemental report.

Item 2C: A standard water test was applied to the stall shower. Leakage was noted within the subarea. Remove the tile from the floor and the base of the walls of the stall shower. Install a leak proof pan with subdrain, and replace tile to a responsible match. An exact match of existing tile is not guaranteed. Reuse existing shower door. NOTE: If damage is discovered after tile is removed or other tiles adjacent to this area become loose or unbonded, such will be outlined on a supplemental report with a price quote for necessary repairs.
