REPORT TO LAW & LEGISLATION COMMITTEE City of Sacramento

Title: Nomination of the Ridgeway Hotel located at 912 - 12th Street for listing in the Sacramento Register of Historic & Cultural Resources as a Landmark (M12-016)

Attachment 2: Nomination Forms

#3a. Description [continued]

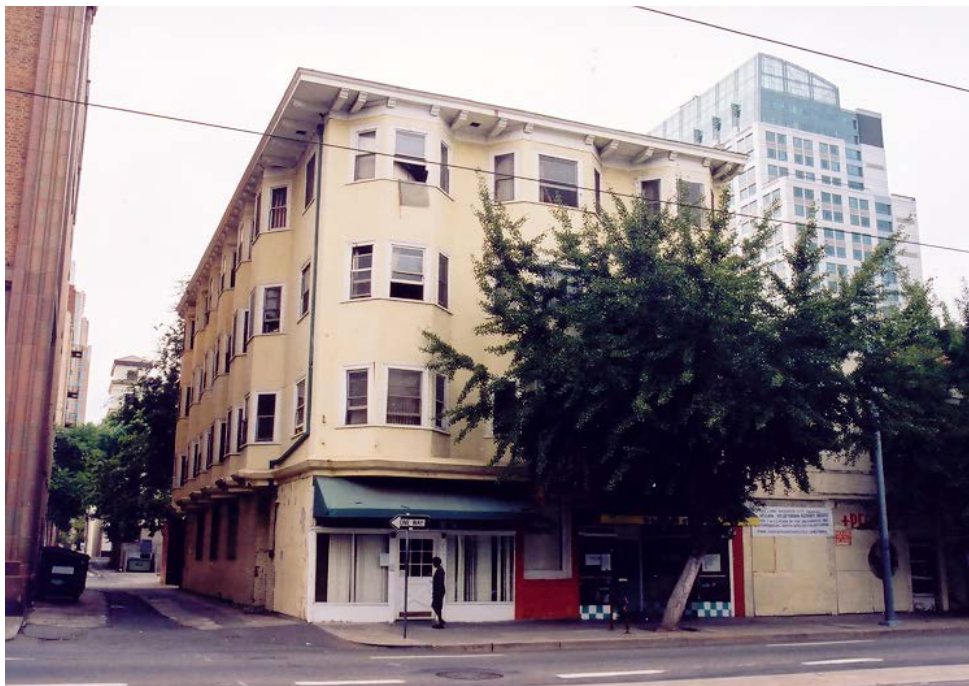
P5b. Description of Photo:

View of east façade on 12th Street and south elevation with bays on the alley, View to northwest.

The four story hotel structure is located in downtown Sacramento on 12th Street adjacent to an alley between I and J Streets. The building is sited on a slab on grade on a 40 x 80 foot lot. The first story is brick, and the building above is wood frame. There is no basement. The building reflects minor Craftsman Style influences with the large brackets supporting the roof overhang and the flared bases of the bays above the first floor. The prominent south and east elevations contain vertical 'columns' of angled bays that project from the walls of the building from the second floor to the roof. The bays each contain three windows, and each window is double hung with wood sash. The sides and façade of the building have been re-surfaced with stucco.

The bases of the upper floor angled bays project from the east façade above the shop canopies and shop openings.

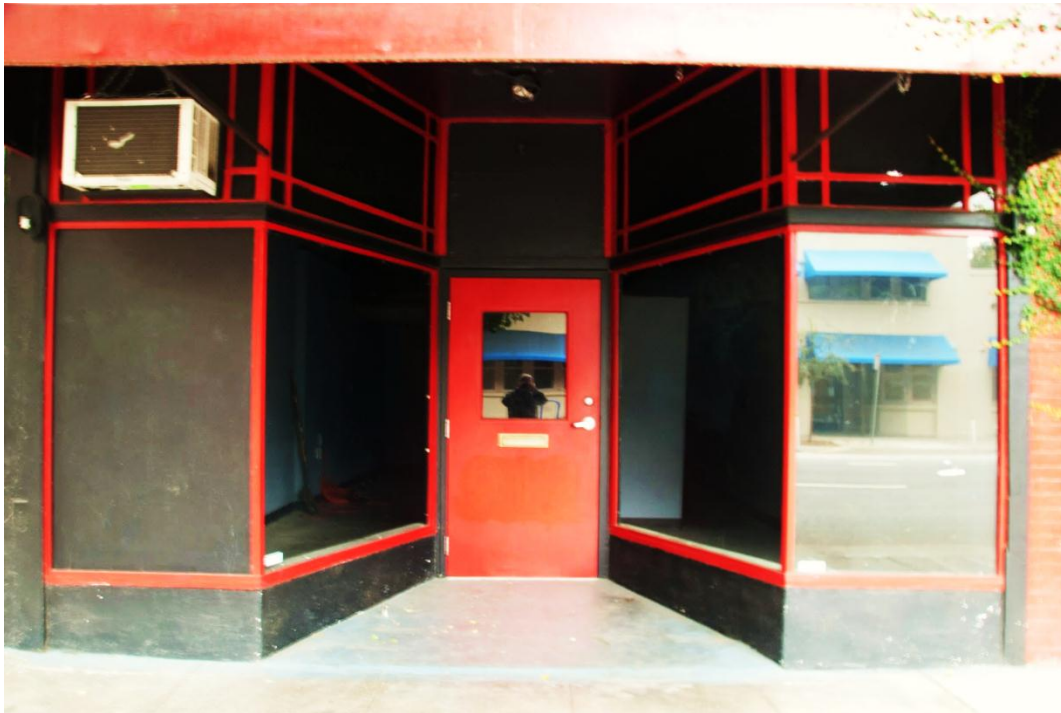
Retail store front on ground level, north side. View to the west.

The street level facade of the building on 12th Street currently contains two different commercial units that flank the original entry to the hotel upstairs. The northerly one contains an angled recessed entry off the sidewalk flanked by show windows beneath clerestory windows. The one on the south has show windows beneath the clerestory windows, and an entry flush with the sidewalk. The original hotel entrance was a slightly recessed doorway off the sidewalk that led to the upstairs rooms. This door, located between the two shops, has been closed off from the street with a block of concrete at sidewalk level. The main entrance to the hotel has been shifted through the shop on the south with interior stairs to the upper rooms. Each separate unit has its own entry canopy, including the hotel. The southerly shop's canopy was originally canvas or metal over an angled metal frame. The small rectangular hotel canopy is trimmed ornamentally and the frame projects from the building with divisions for small hanging colored glass panels, typical of the era. The northerly shop's canopy is a non-historic shed-roof shaped metal sheet.

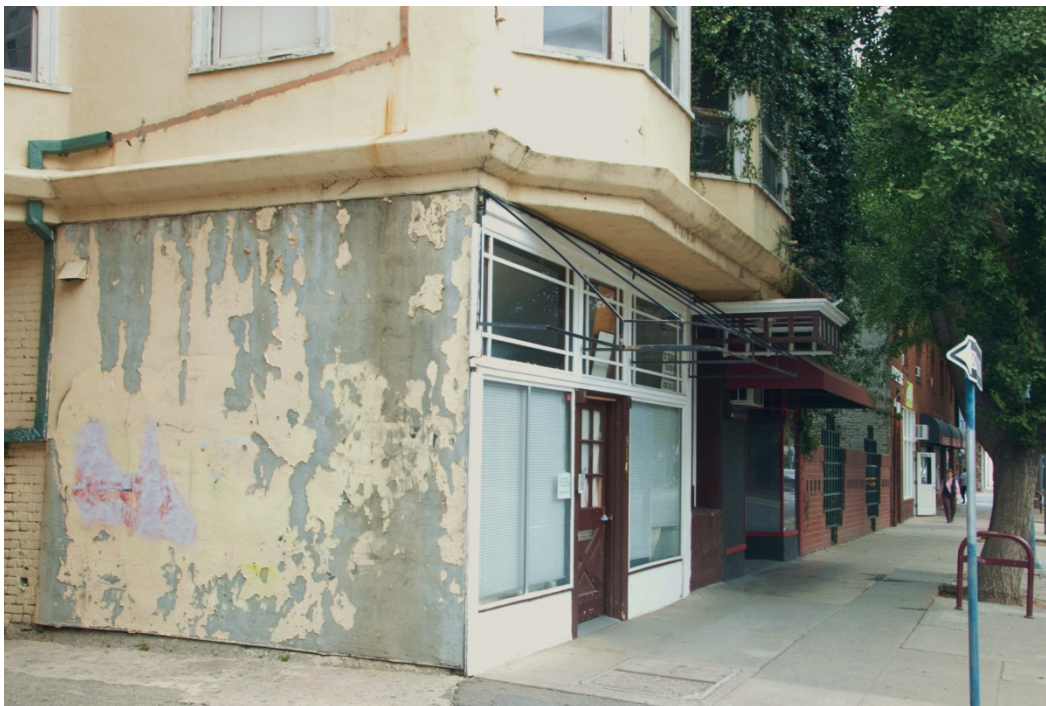
Retail storefront on south side. View to northwest.

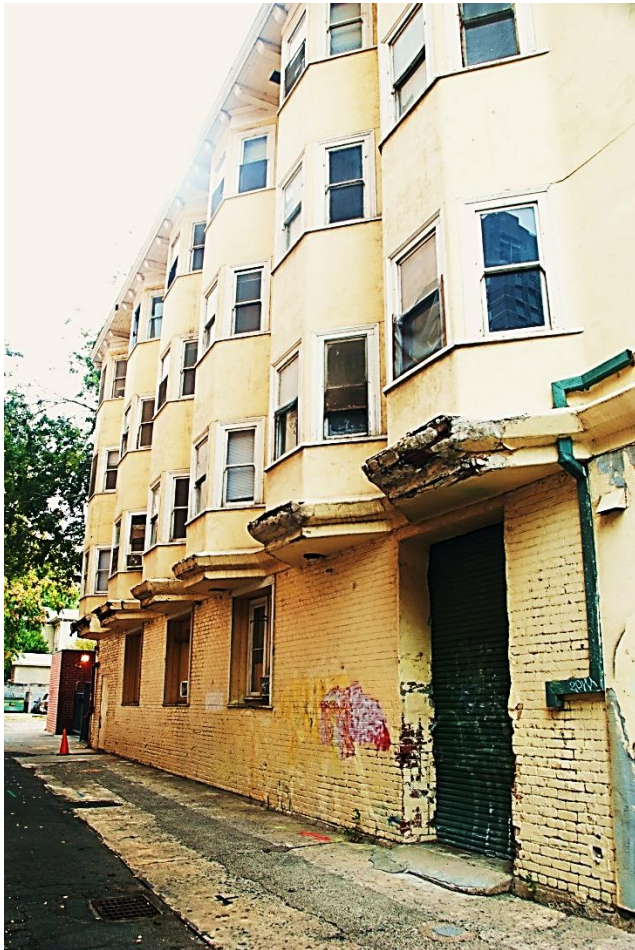
Alley elevation showing ground floor openings and banks of bay windows on upper floors. View to the northwest.

The stucco on the bays may have been overcoated at that time (1988), perhaps partly due to damage to the bases at the alley from truck impacts over time. Although there is indication that there were bollards in the alley at one time to protect the building, they were removed. There are patches in the alley floor that appear to indicate where they were once located. It appears that their removal has allowed continued damage by trucks to the bases of the bays.

On the south elevation between the westernmost two 'columns' of bays, there are disturbances in the stucco at each floor that suggest the possible earlier location of doorway openings to what may have been a fire escape. A second interior fire stair was added to the building in 1988, perhaps removing the necessity of a fire escape on that wall. The 1952 Sanborn map indicates a fire escape on the northern end of the east facade elevation. There is currently no visual evidence of that fire escape. There is an uneven small-vehicle size opening in the brick with a metal roll-up door on the south wall at the alley, near the front of the building that appears to have been added to serve as a trash collection site.

The physical condition of the building is poor, with deterioration at the bases of the angled bays along the alley, due to damage from impacts of trucks using the alley. There is damage due to heavy use, weather, water intrusion from wall and roof leaks, lack of ongoing maintenance, vandalism, and possible metal salvage damage to equipment, etc.

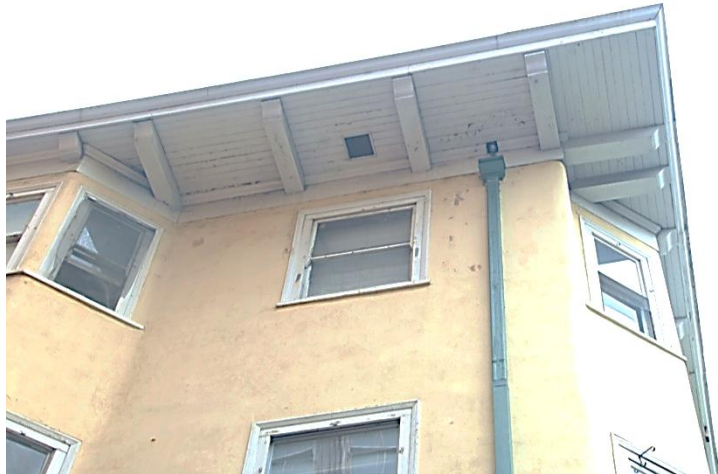
View of mean detail in soffit.

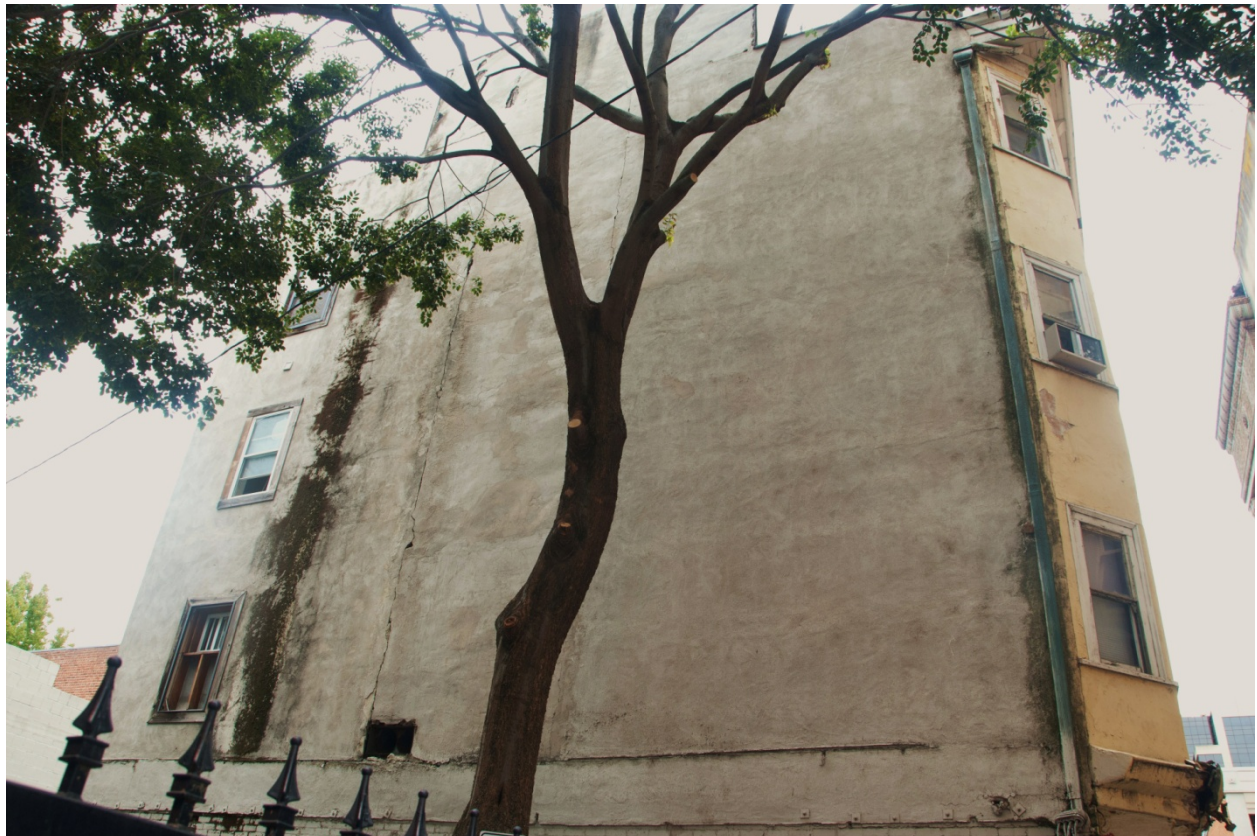
Rear building elevation. View to the east.

An elevator was added to the north end of the west wall in the 1988 remodeling of the building. Evidently there was a 'notch' in the west elevation that was filled in to accommodate the elevator. The lines of the infill are visible in the cracking of the exterior stucco.

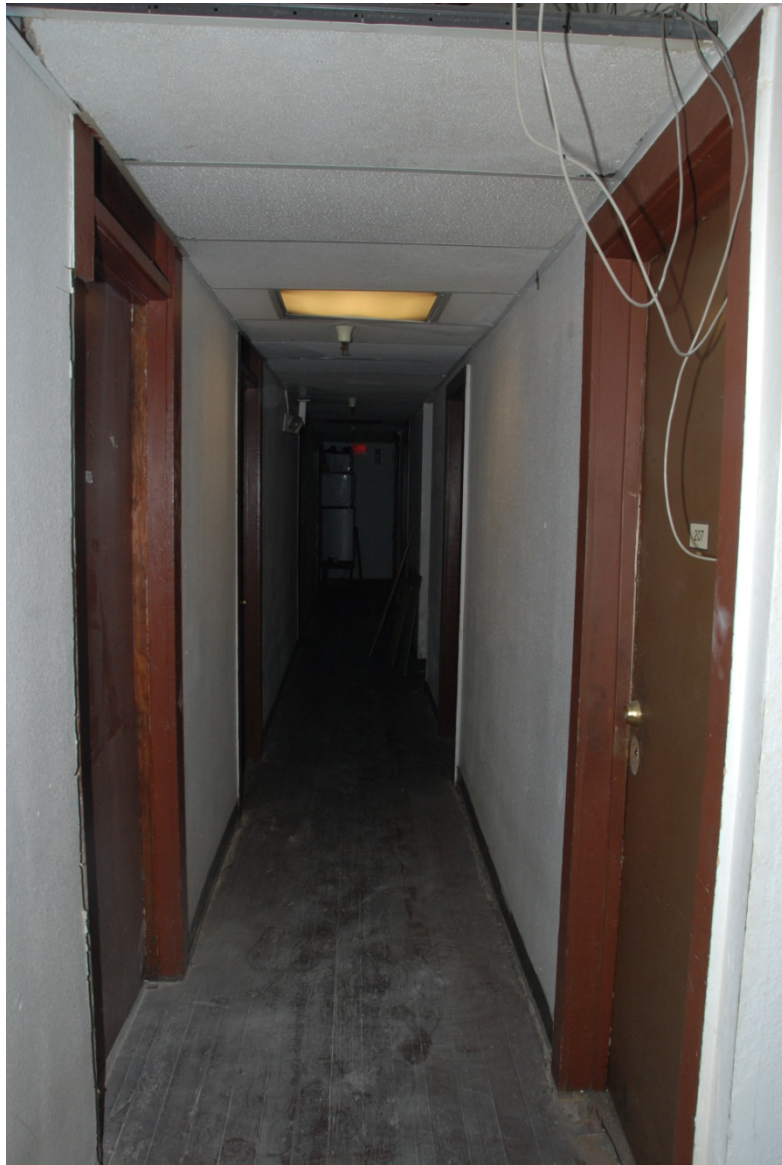
Typical hallway view. The door on left shows a partial view of the original transom molding.

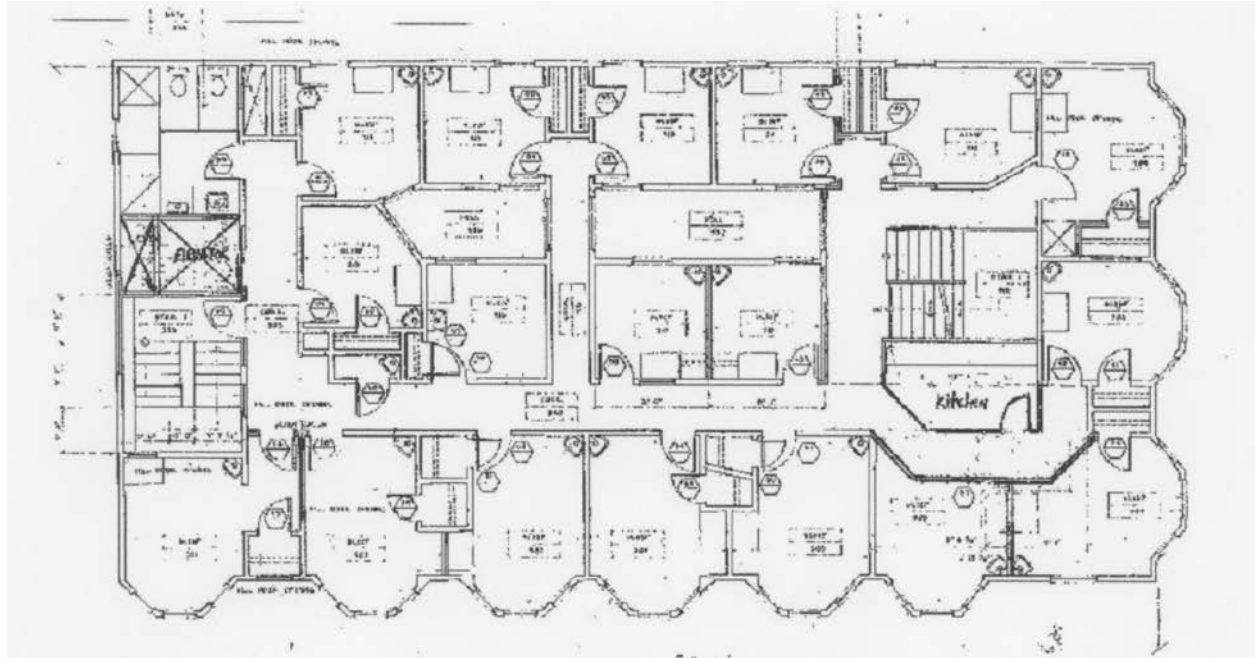
Sketch of 2nd through 4th floor plan.

There are two light wells on the interior that extend to the roof from the second floor. They are surfaced with thin metal sheeting impressed to imitate a brick pattern. The interior hallways are narrow and some of the doors appear to still have transom windows partially obscured by nonhistoric lowered hallway ceilings. The south wall along the alley contains window openings on the ground floor that have been infilled and fitted with smaller windows. There are slight variations in the infill patterns.
